S/17659/Rev.1

REPORT OF THE **SECRETARY-GENERAL** IN PURSUANCE OF PARAGRAPH 5
OF SECURITY COUNCIL RESOLUTION 573 (198'5)

**evaluating the damage caused by the armed aggression perpetrated
by Israel against Tunisian territory on 10 October 1985**

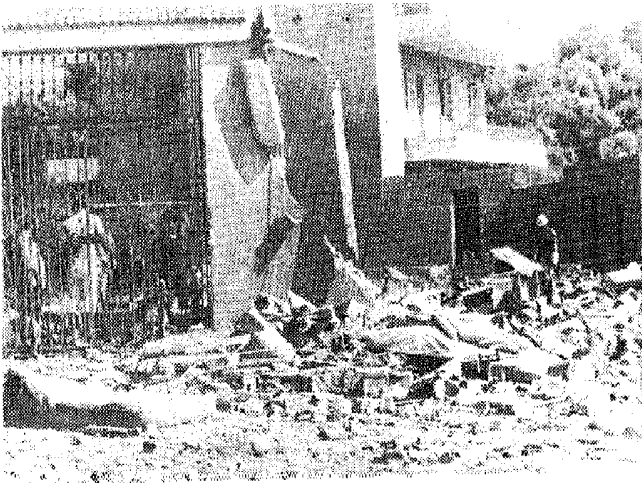
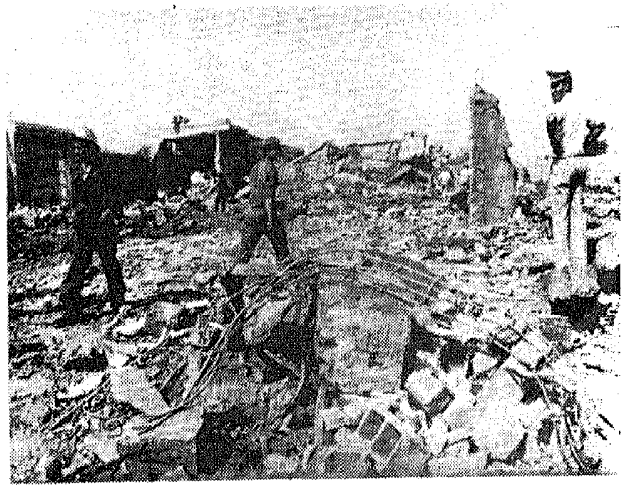
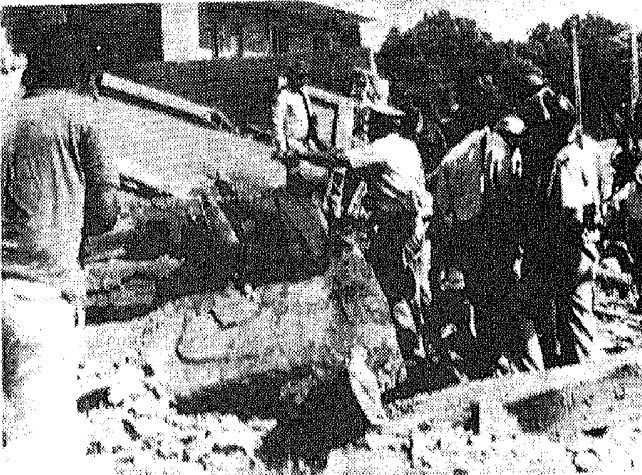
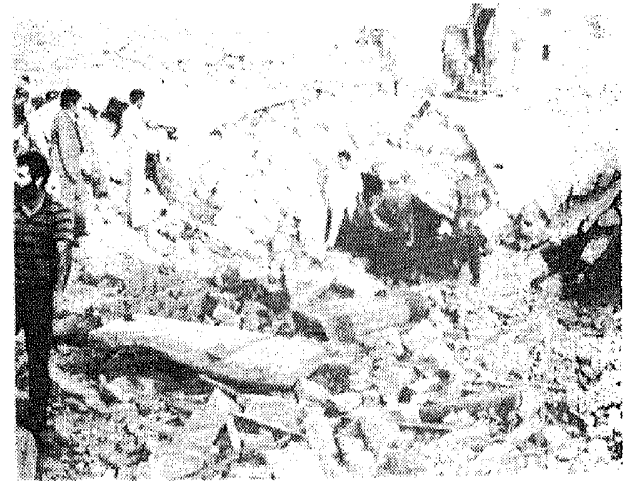
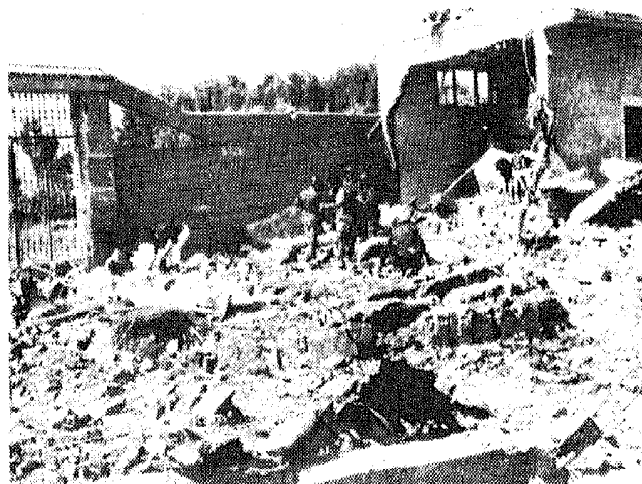
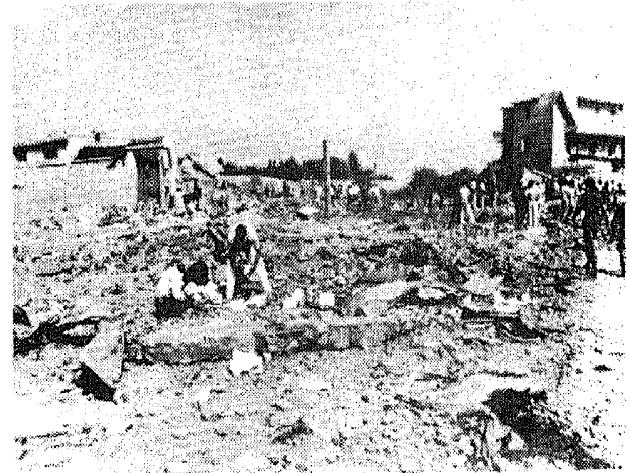
IMMEUBLE HADJ SAID SABTA

This building, situated near the other three described above, was shaken by the **bomb blasts, suffering severe** cracks; stones hurled by the blast pierced holes in the walls, the window-panes were all broken, a **workshop was partially** damaged and rendered unstable, and **several** window roofs were completely **blown off**.

The damage to this building' was estimated on the basis of a **figure** of do-per-cent visible **damage**, without taking into account any hidden damage or **flaw**.
