Environmental Assessment of the Gaza Strip

following the escalation of hostilities in
December 2008 – January 2009

United Nations Environment Programme

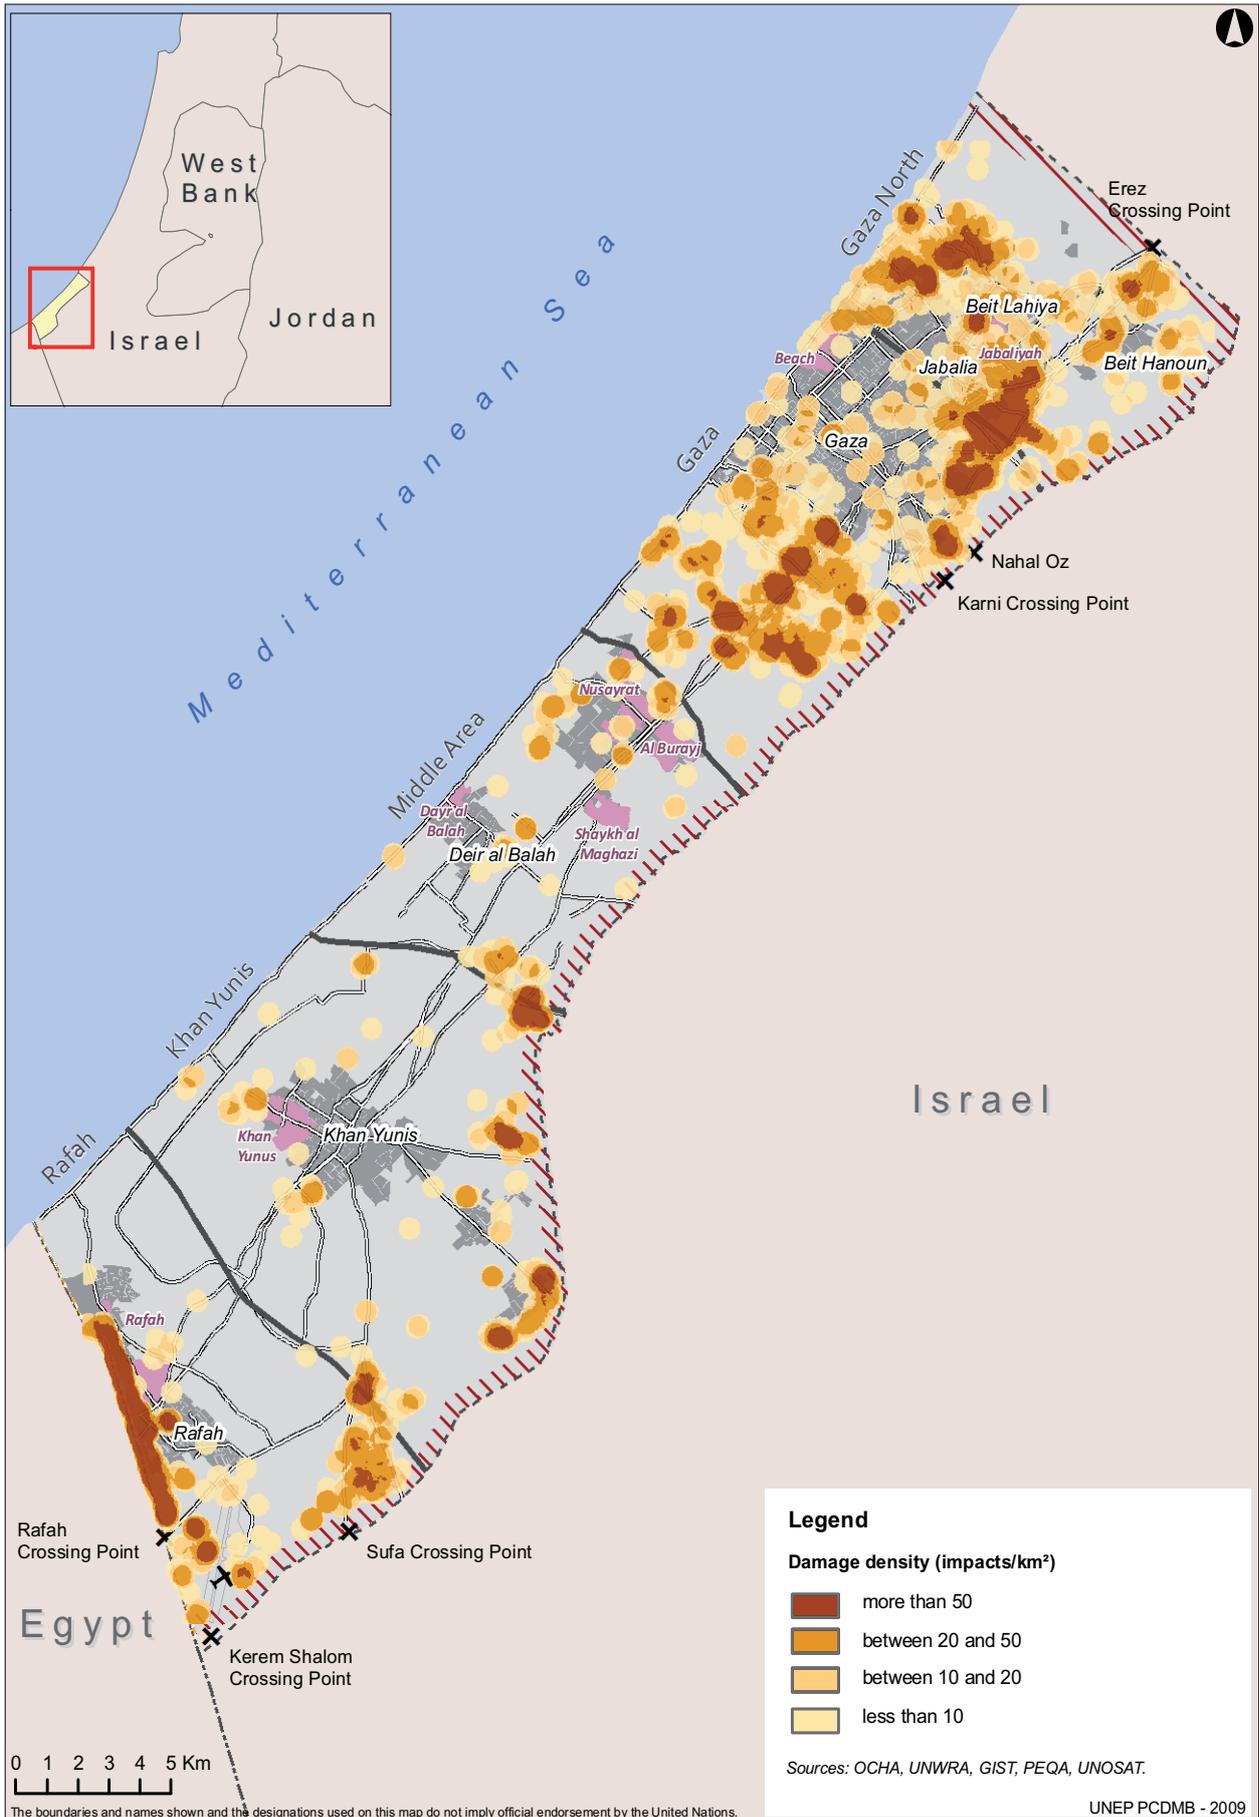
Map 3. Damage analysis map

The limited spatial resolution of the satellite imagery significantly reduces the confidence level for damage identification within dense urban areas. It is highly probable, therefore, that the damage assessment underestimated the actual building and infrastructure damage at the time of satellite image acquisition.

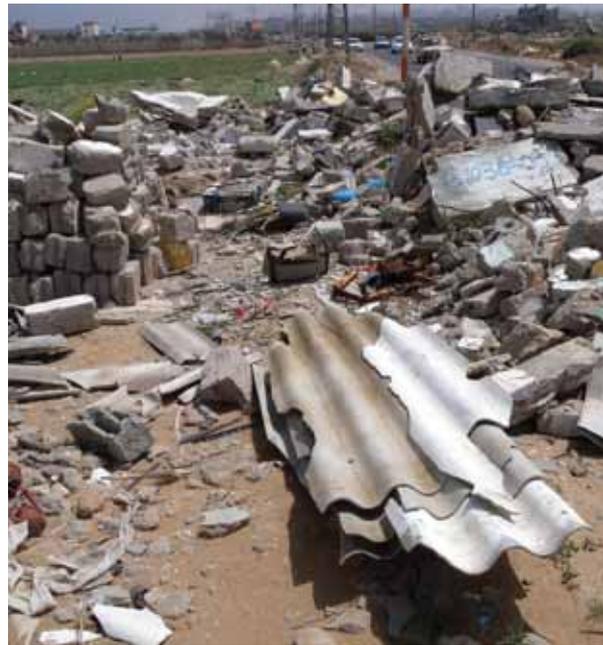
Asbestos in rubble

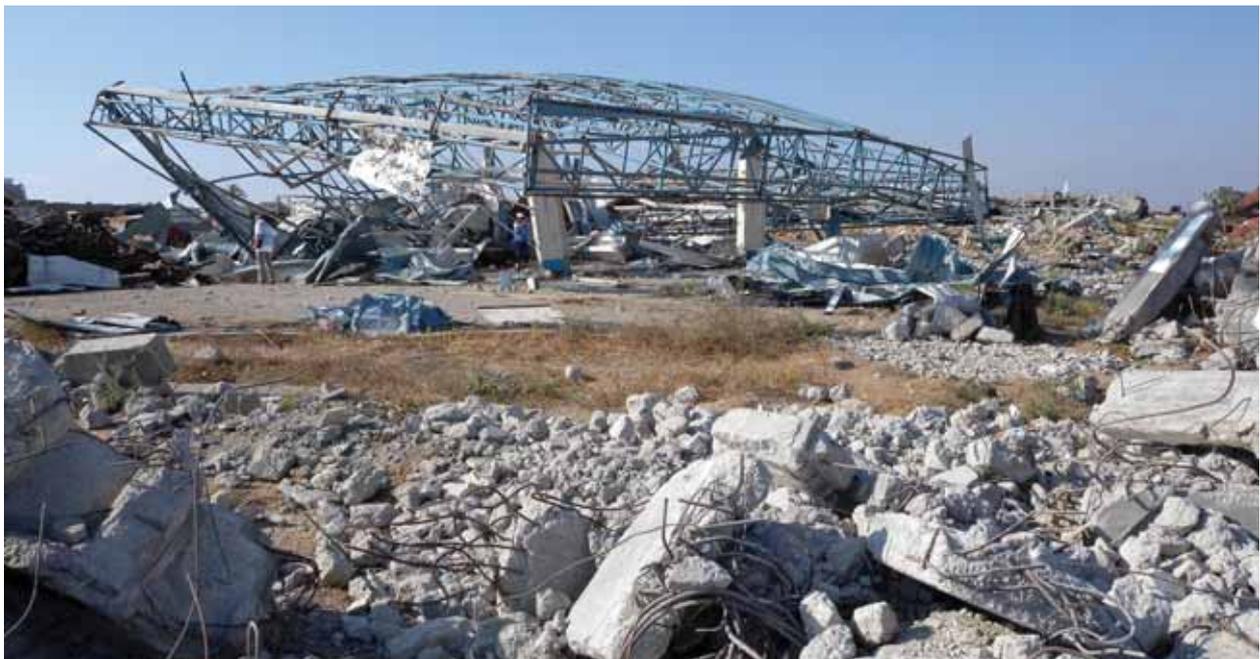
Demolished gasoline station in Northern Gaza Strip

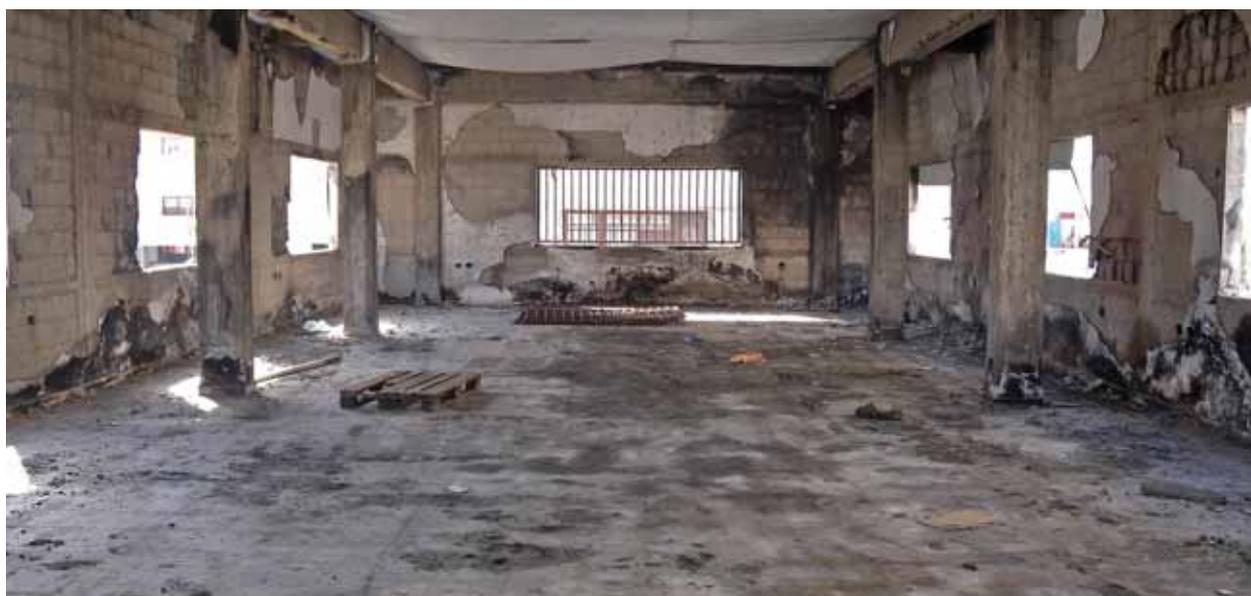
In addition, a number of buildings were hit by ammunition that caused fires and partial or total destruction of the structure. Building fires contaminate the building and/or the resulting rubble with polynuclear aromatic hydrocarbons (PAHs) and, if chlorinated compounds are present, with dioxins and furans, all of which are extremely hazardous.

Burnt out interior of the Red Crescent building in Gaza City

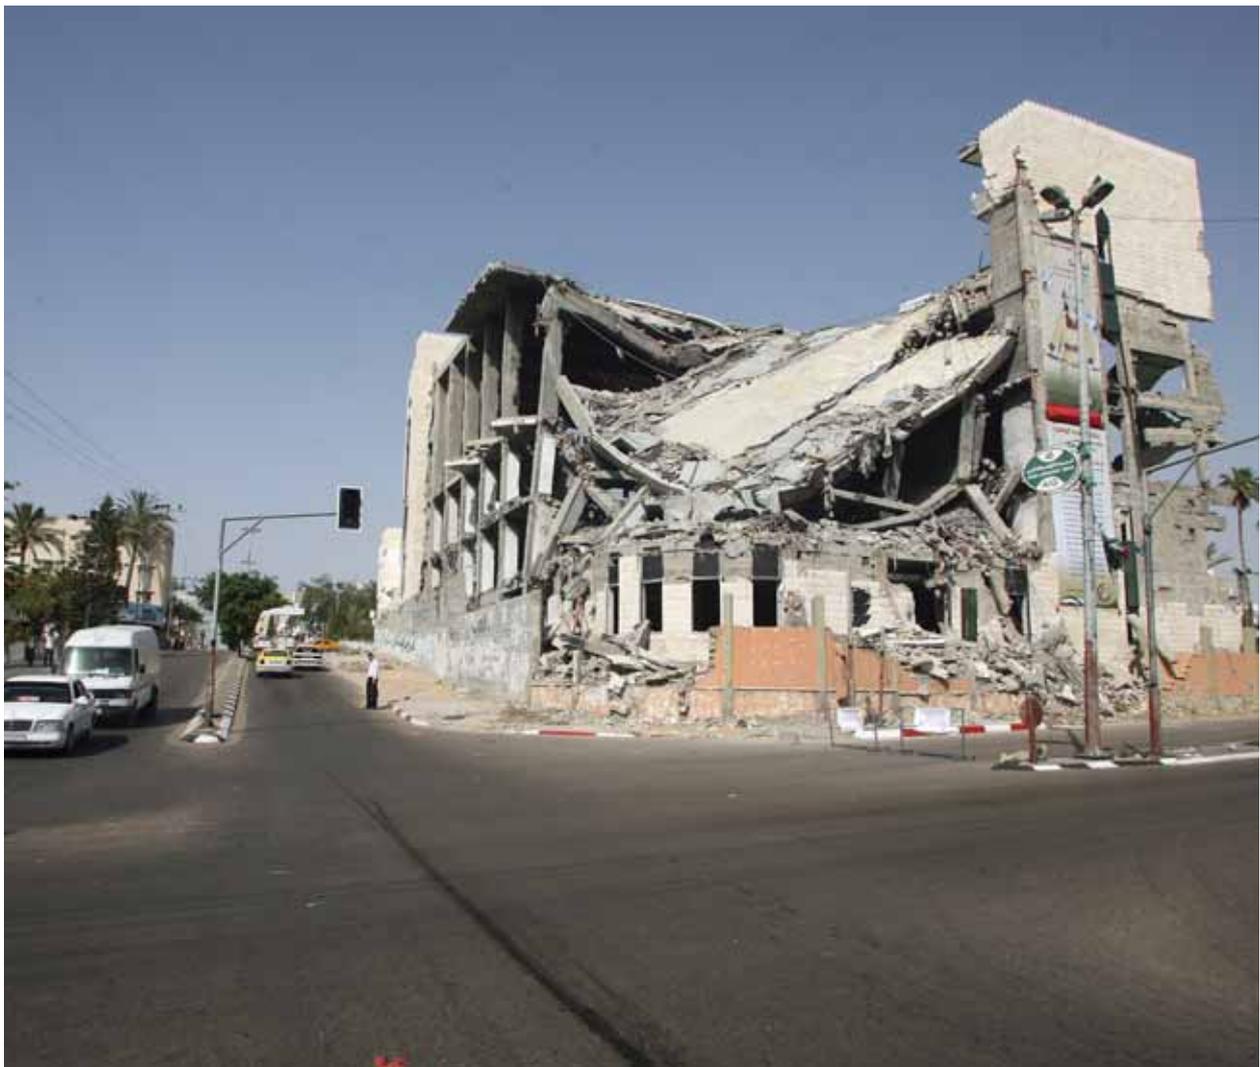
Hanging rubble in partially demolished buildings, like this one in Gaza City, poses a major challenge

However, the problem urgently requires a solution which, considering the special circumstances in the Gaza Strip, should ideally not only be low tech and low cost, but also in line with international standards of work health and safety. It is therefore recommended to engage a professional health and safety expert to assist the teams undertaking the demolition.

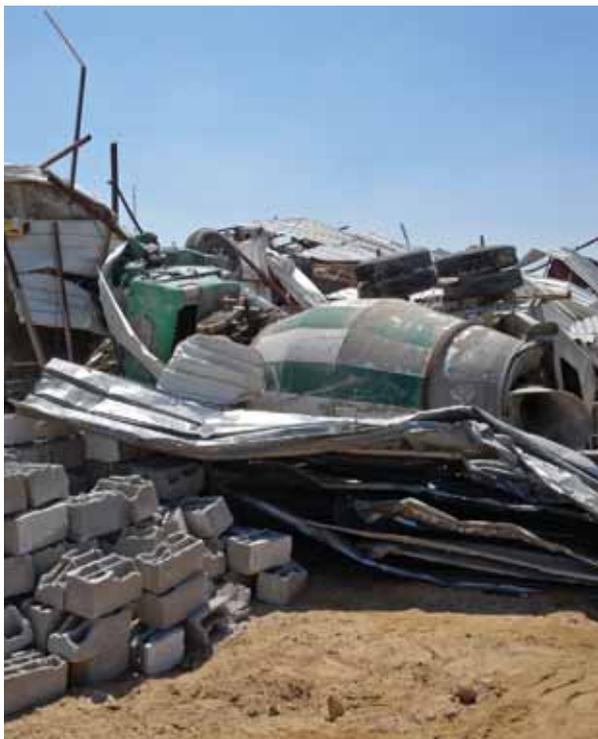
Bulldozed cement plant near Rafah

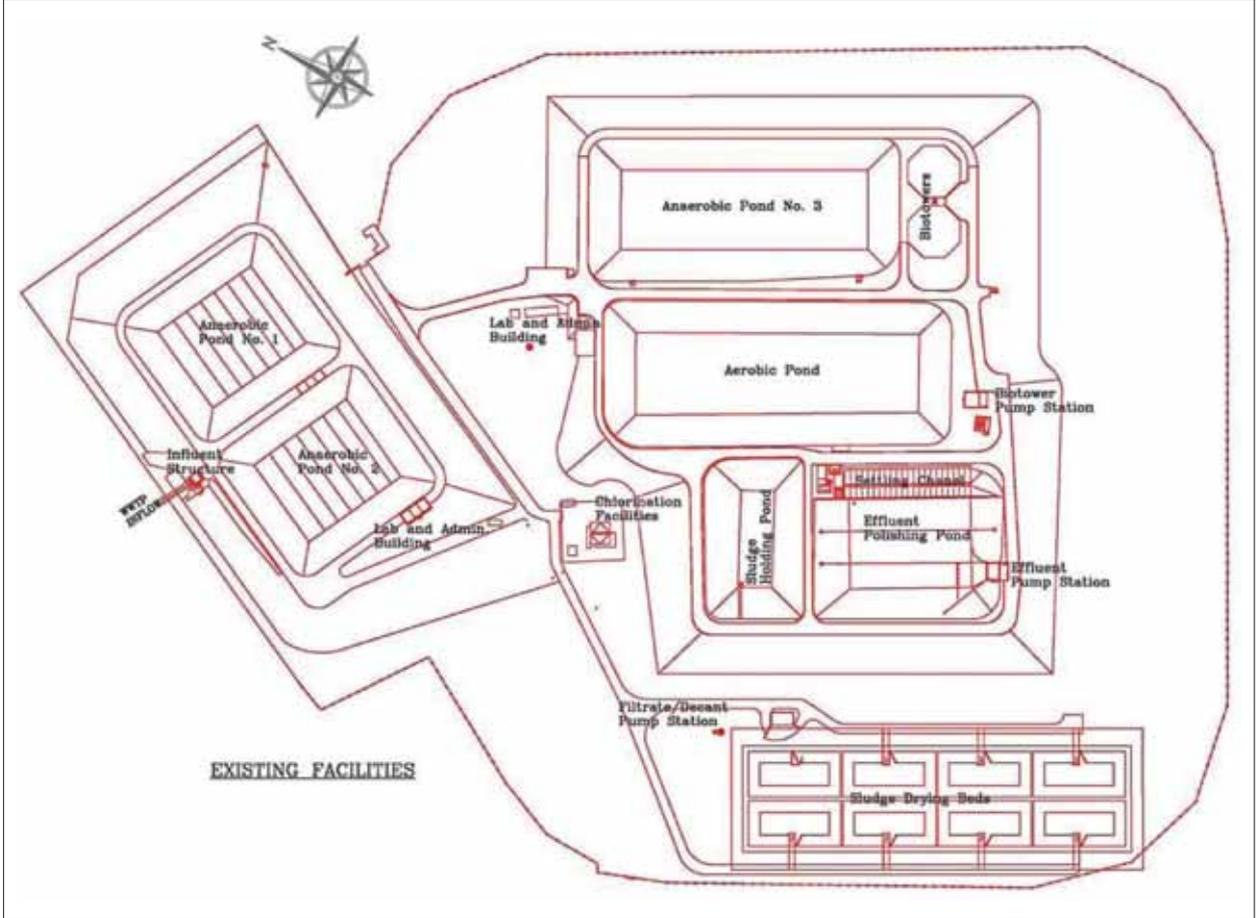
Figure 1. Layout of the Az Zaitoun wastewater treatment plant⁵

During the recent conflict, anaerobic pond no. 3 was damaged, its embankment destroyed, and more than 100,000 m³ of wastewater and sludge spilled into adjacent agricultural areas.⁶ UNDP estimated that 55,000 square metres of agricultural land were impacted by this spill.

As can be seen from Figure 1,⁵ the CMWU is planning to upgrade the Gaza sewage treatment plant in the area of the waste deposits by constructing two more trickling towers (new “bio-towers”). The location chosen for these towers is the waste dump site mentioned previously. However, this is not stable ground and the waste will have to be removed before any construction begins.

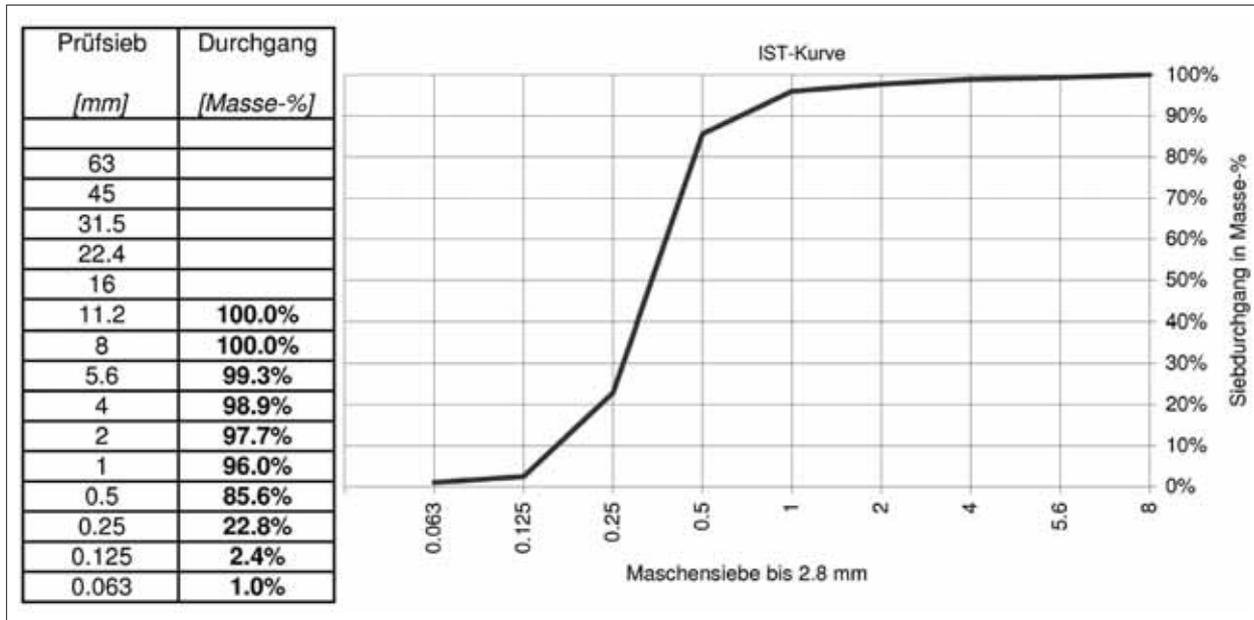
Figure 2. Grain size analysis of sample 05-SOIL-02

The curve in Figure 2 shows that the grain size of 90 percent of the sample size varies between 0.125 mm and 1.0 mm. According to the grain size analysis results, the hydraulic conductivity is $k_f = 2.6 \times 10^{-4}$ m/s, which is average to high for sand. The underlying soil is highly permeable.

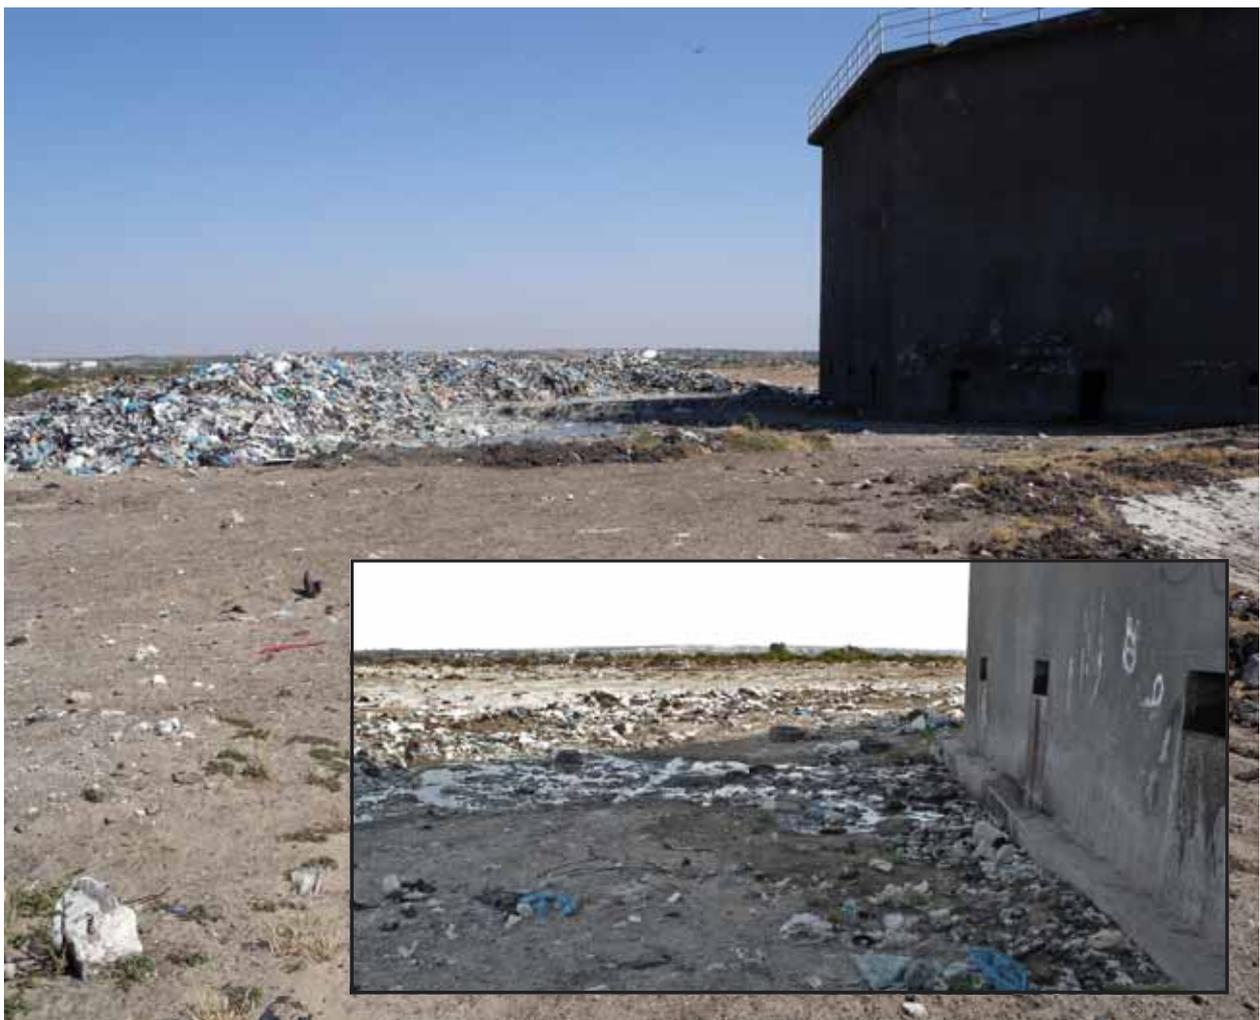
Az Zaitoun wastewater treatment plant trickling tower leakage

Leakage from the Az Zaitoun wastewater treatment plant trickling towers onto an adjacent pile of waste

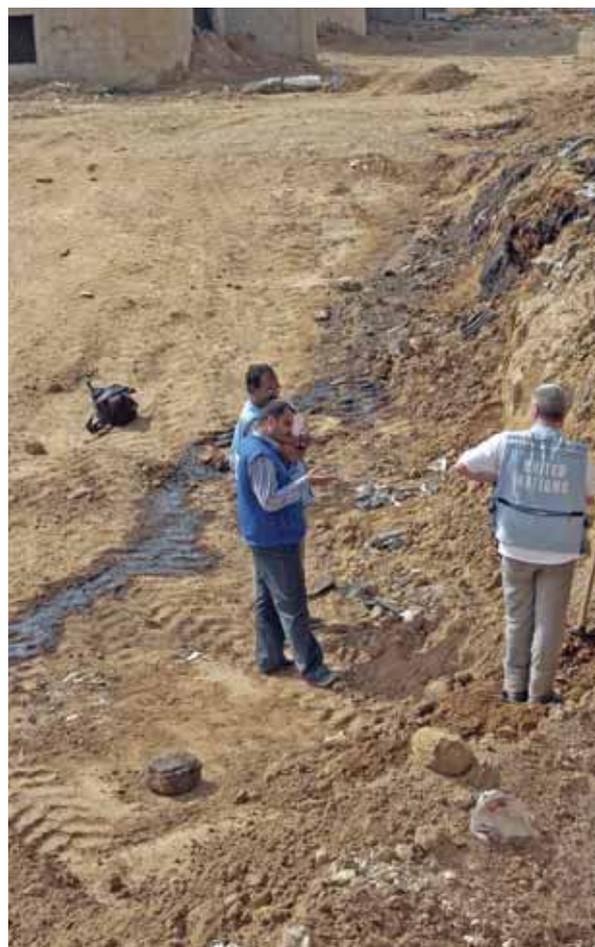
No base lining or leachate control systems were found in the landfill sites visited in the Gaza Strip. Leachate was observed on some sites, such as in the Rafah landfill. In these cases, the risk of groundwater contamination is only limited by soil permeability and desiccation, and the soil's ability to absorb contaminants. The soil pathway in landfill areas usually affects outflows of landfill leachate on neighbouring land. These effects are usually very limited and restricted to a few thousand square metres immediately around the landfill. The soil contamination in this case depends on the organic and inorganic contaminants in the leachate, which may vary widely. However, over a period of time, the leachate can reach and pollute the groundwater.

Landfill leachate leaking from Rafah landfill

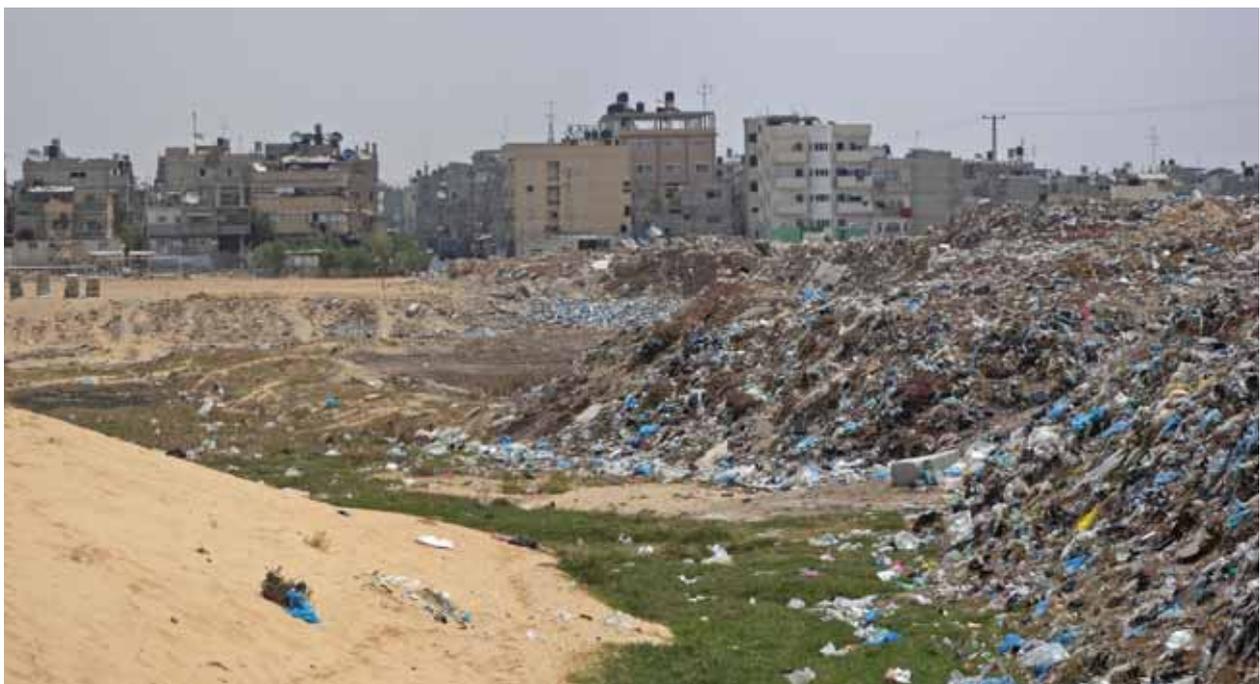
The decommissioned Tal El Sultan landfill site was reopened during the recent hostilities

The site should be closed and its contents removed to a properly located and designed landfill site. After due diligence has been carried out, the site should be restored.

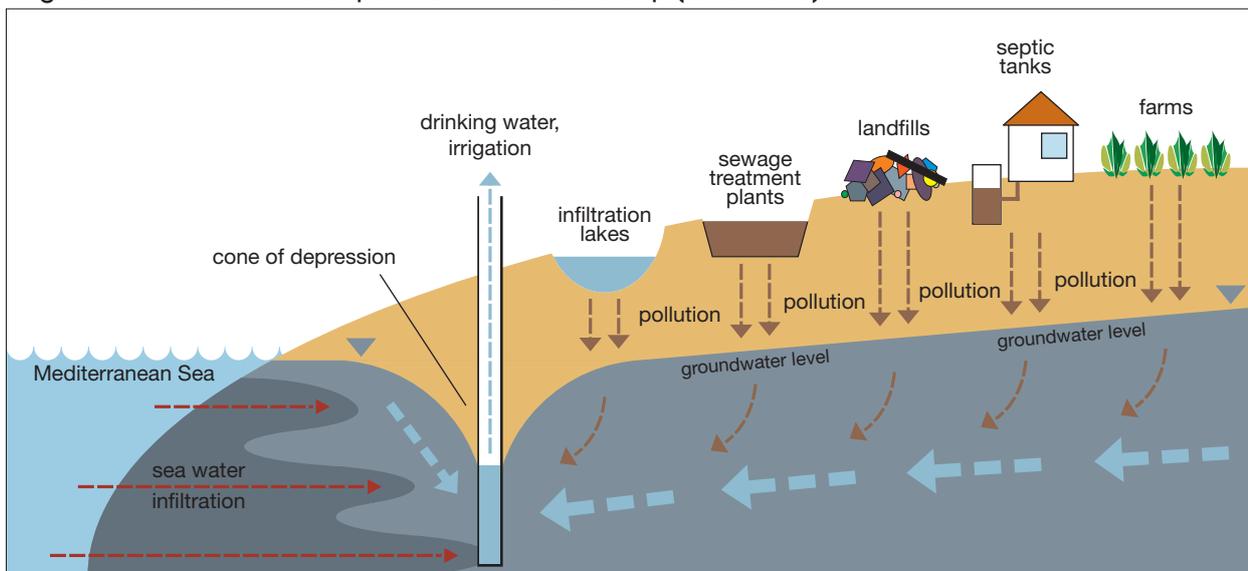
Figure 6. Groundwater pollution in the Gaza Strip (schematic)

levels are declining in areas where abstraction is greatest, while salt water infiltration from the sea is causing the aquifer to become more saline. The salinity levels in most parts of the Gaza Strip are now above the WHO approved guideline of 250 mg/litre, and often much higher.

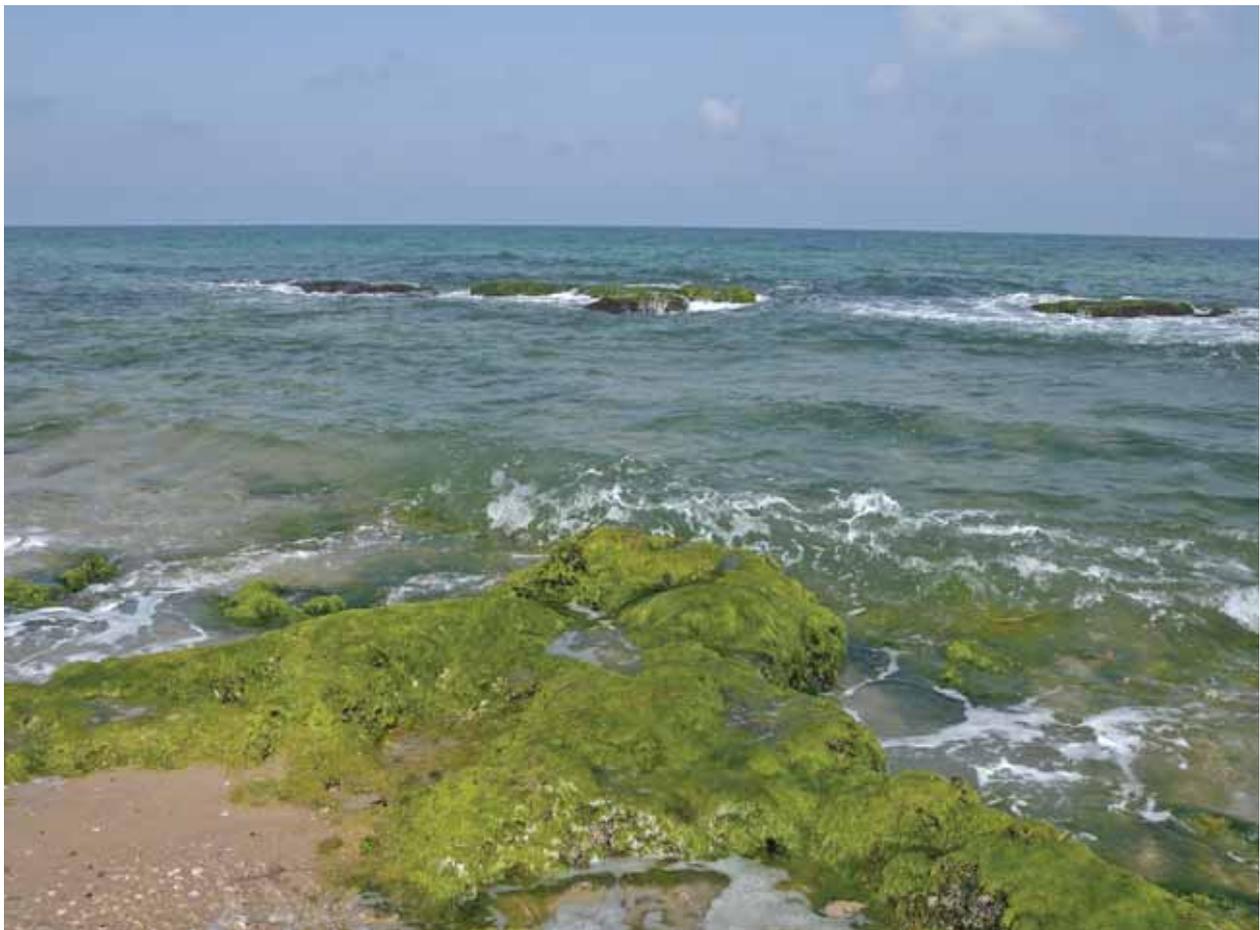
Prolific algae growth due to sewage outflow into the Mediterranean Sea

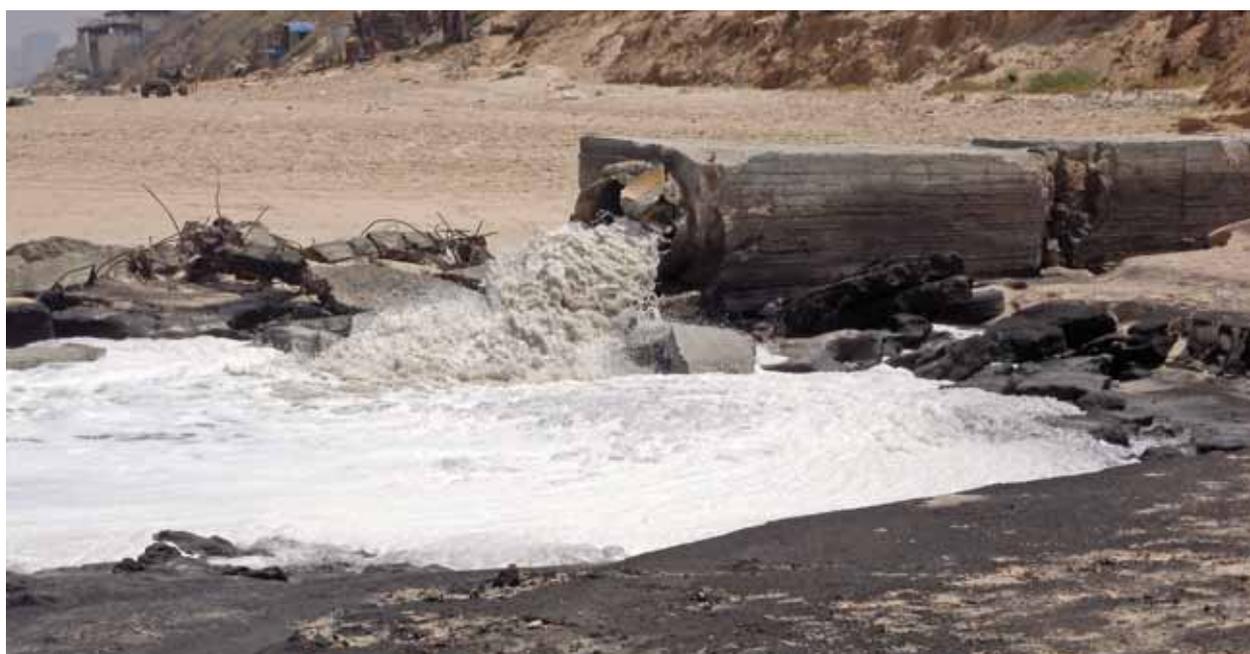
One of many outfalls of untreated sewage into the Mediterranean Sea
