Environmental Assessment of the Areas Disengaged by Israel in the Gaza Strip

United Nations Environment Programme

First published in March 2006 by the United Nations Environment Programme.

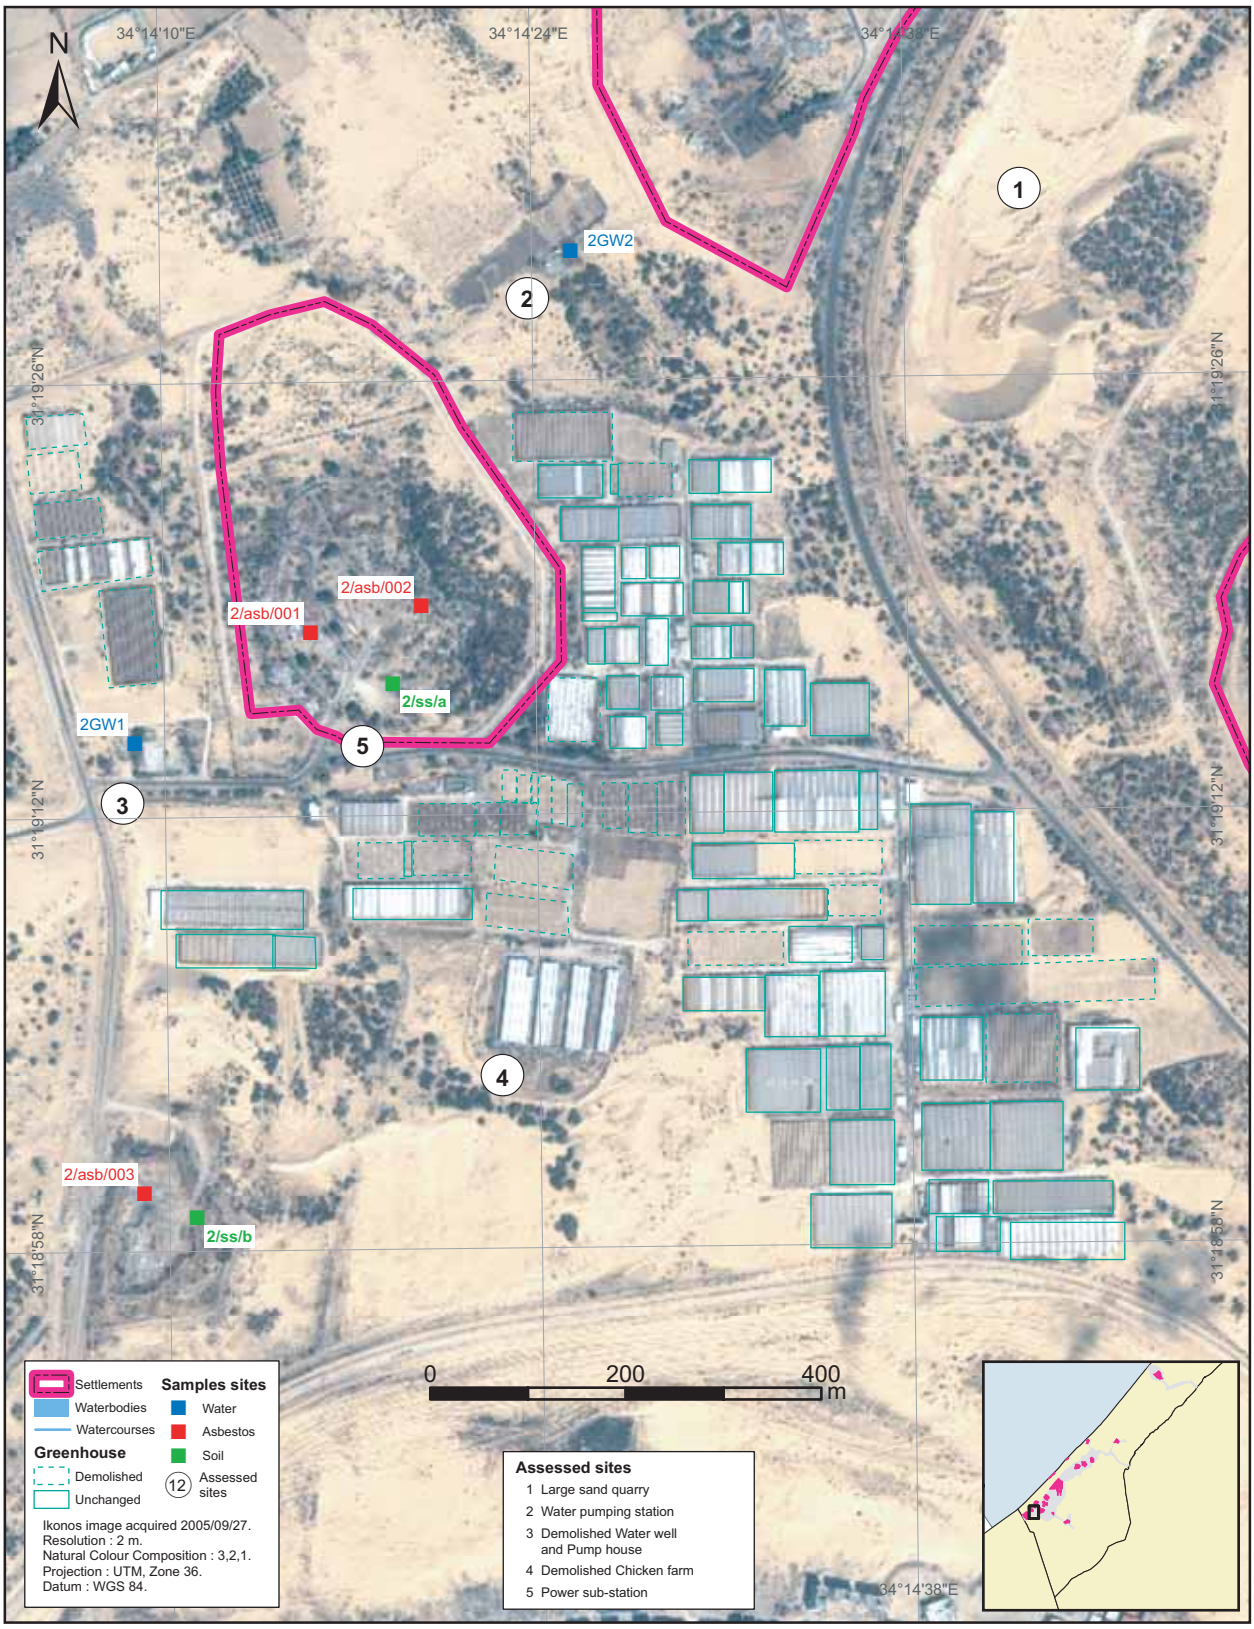
Map 7. Slav

All contaminants identified have potential adverse impacts and would require the restriction of landuse if left in situ. It is therefore recommended that the material be excavated and removed from the current location.

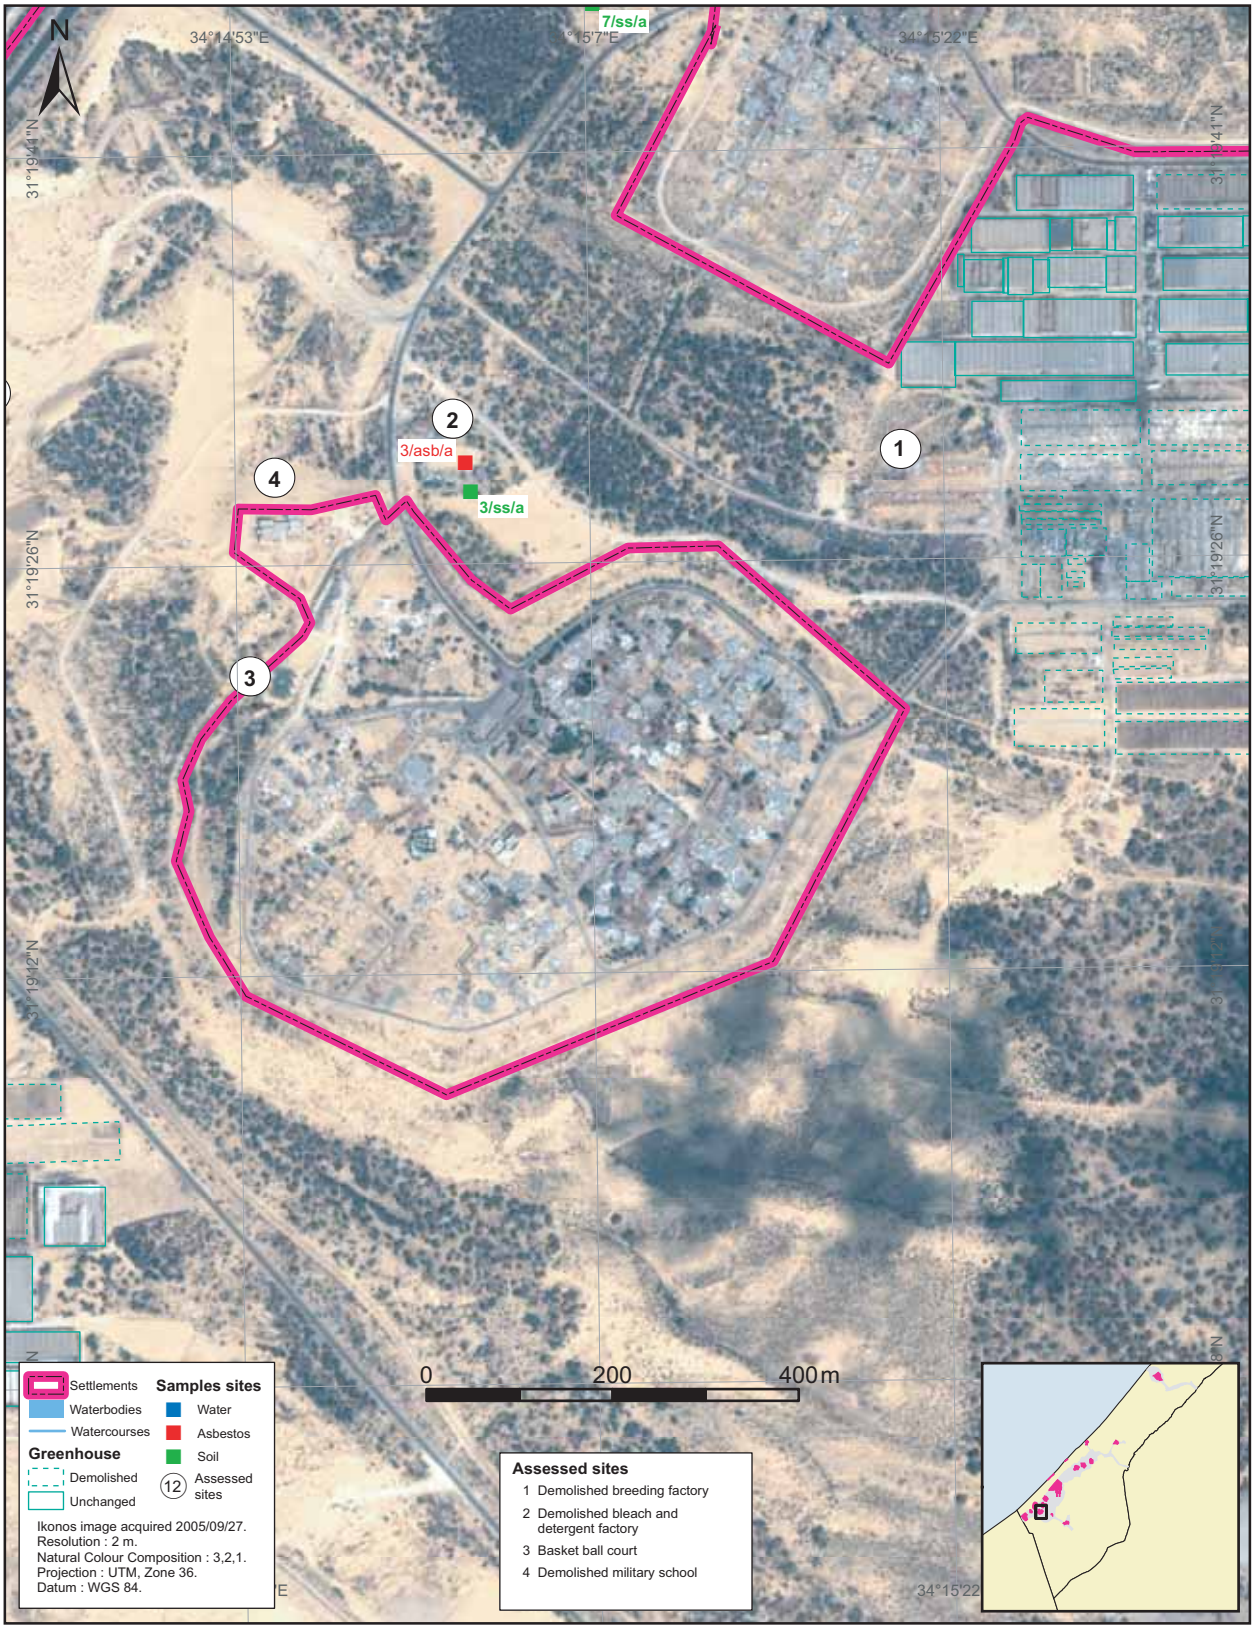
Map 8. Bnie Atsmon

A view of the Bnei Atsmon site where industrial waste had been discarded.

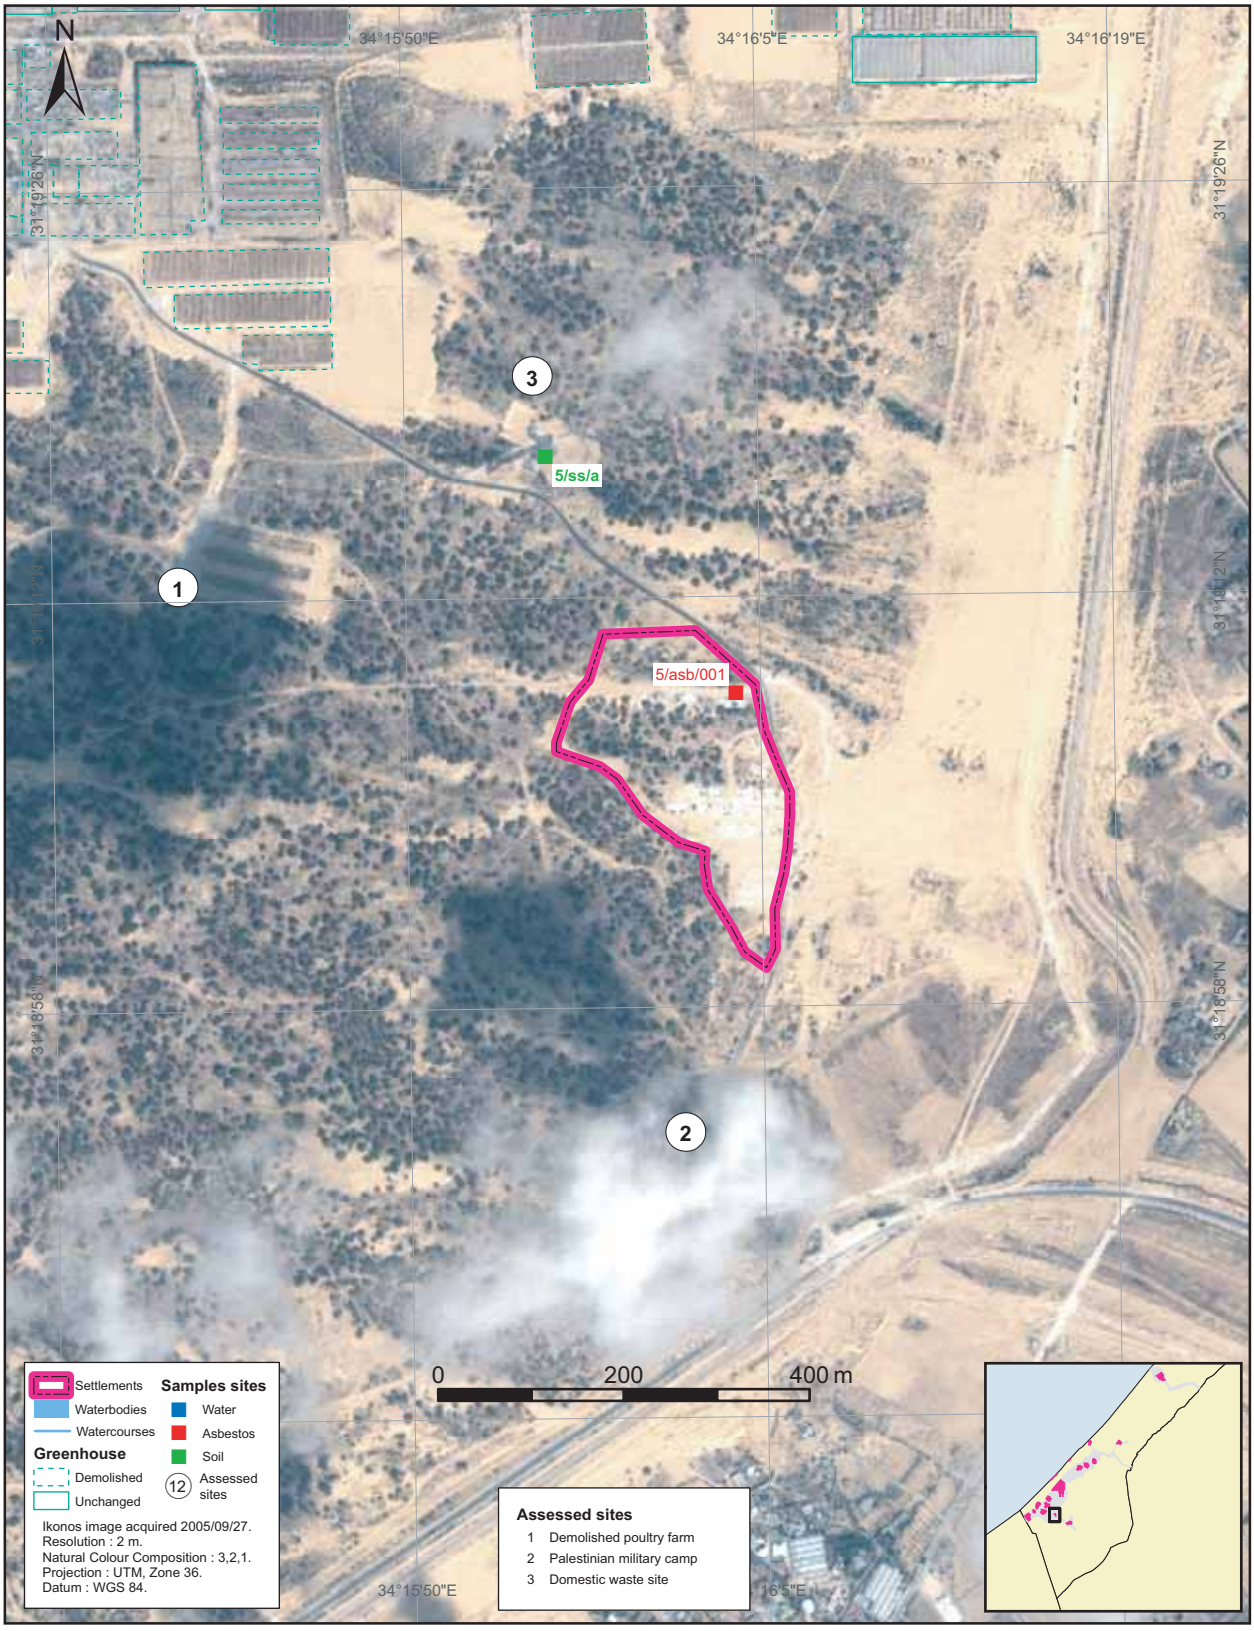
Map 10. Karem Atsama

The waste disposal site in Karem Atsama

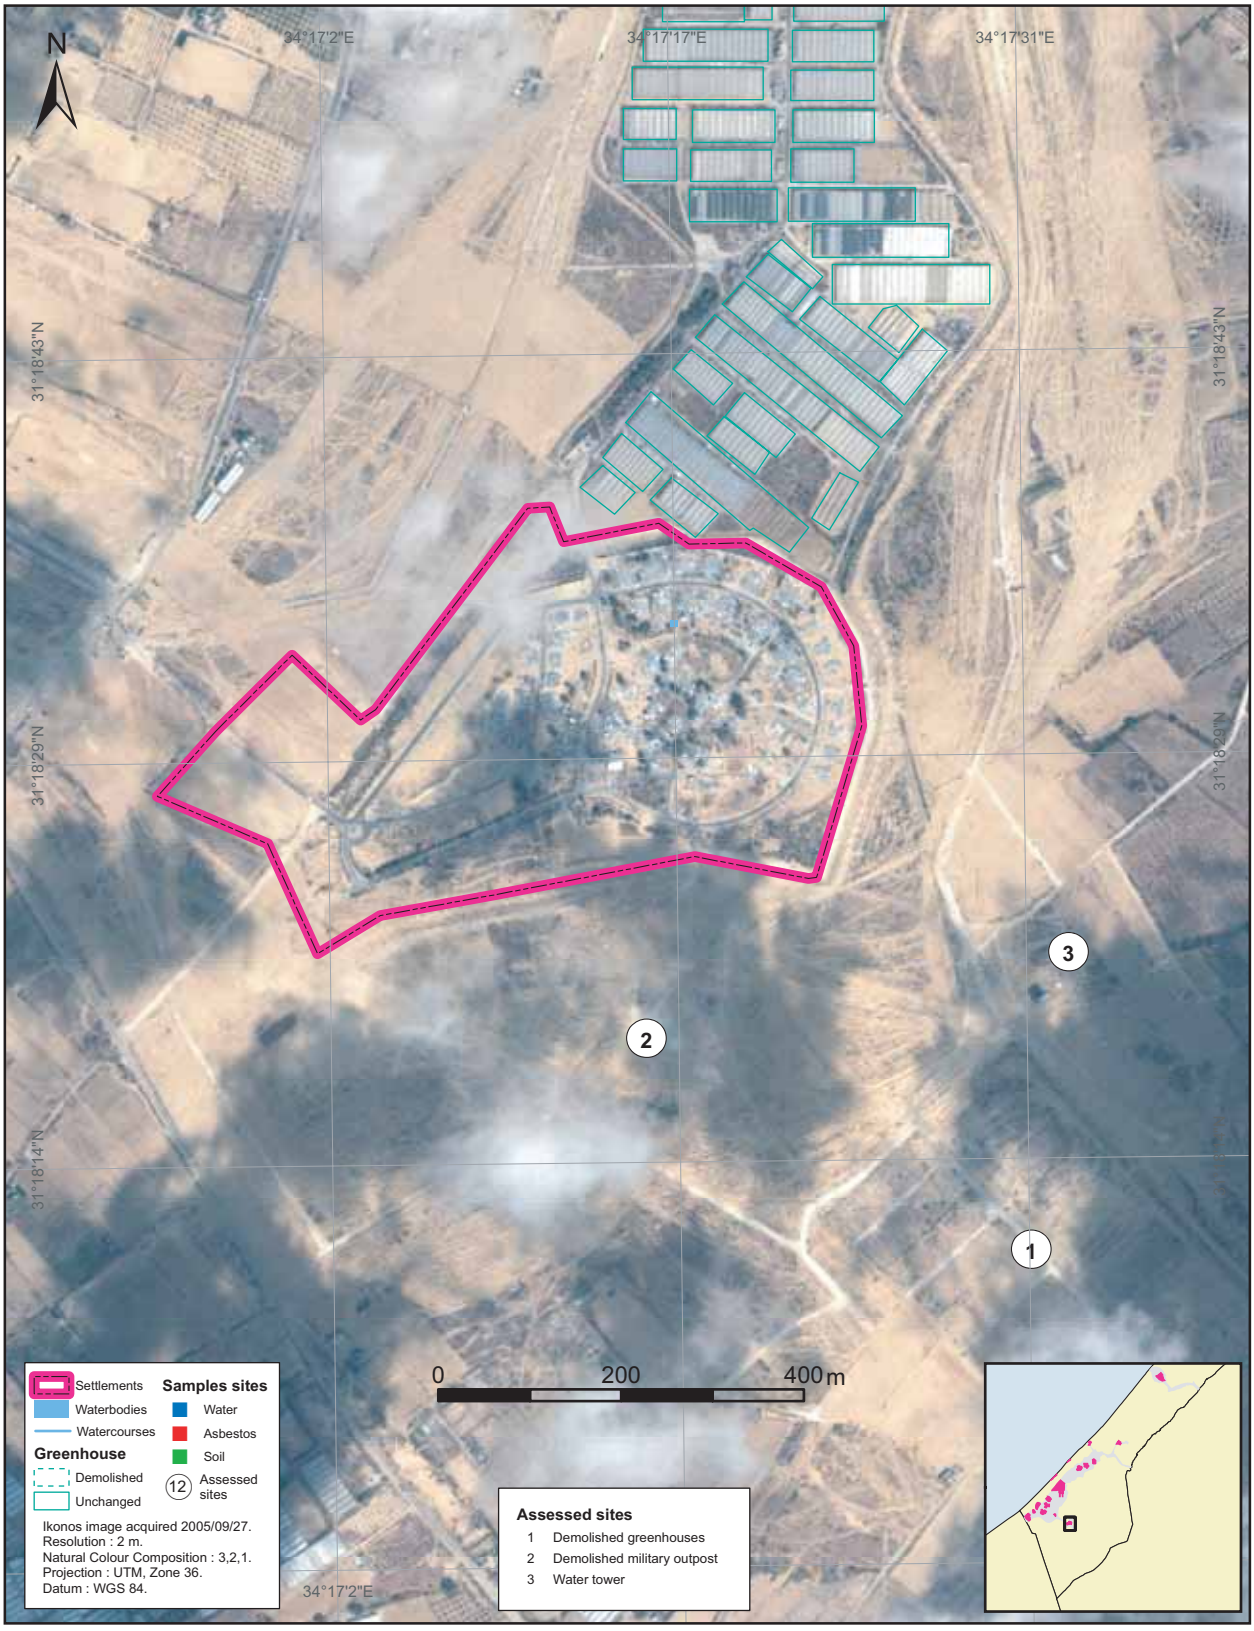
Map 11. Morag

Notes:
A sample of the roofing felt from a demolished building was taken for analysis. Asbestos was not detected in the sample.

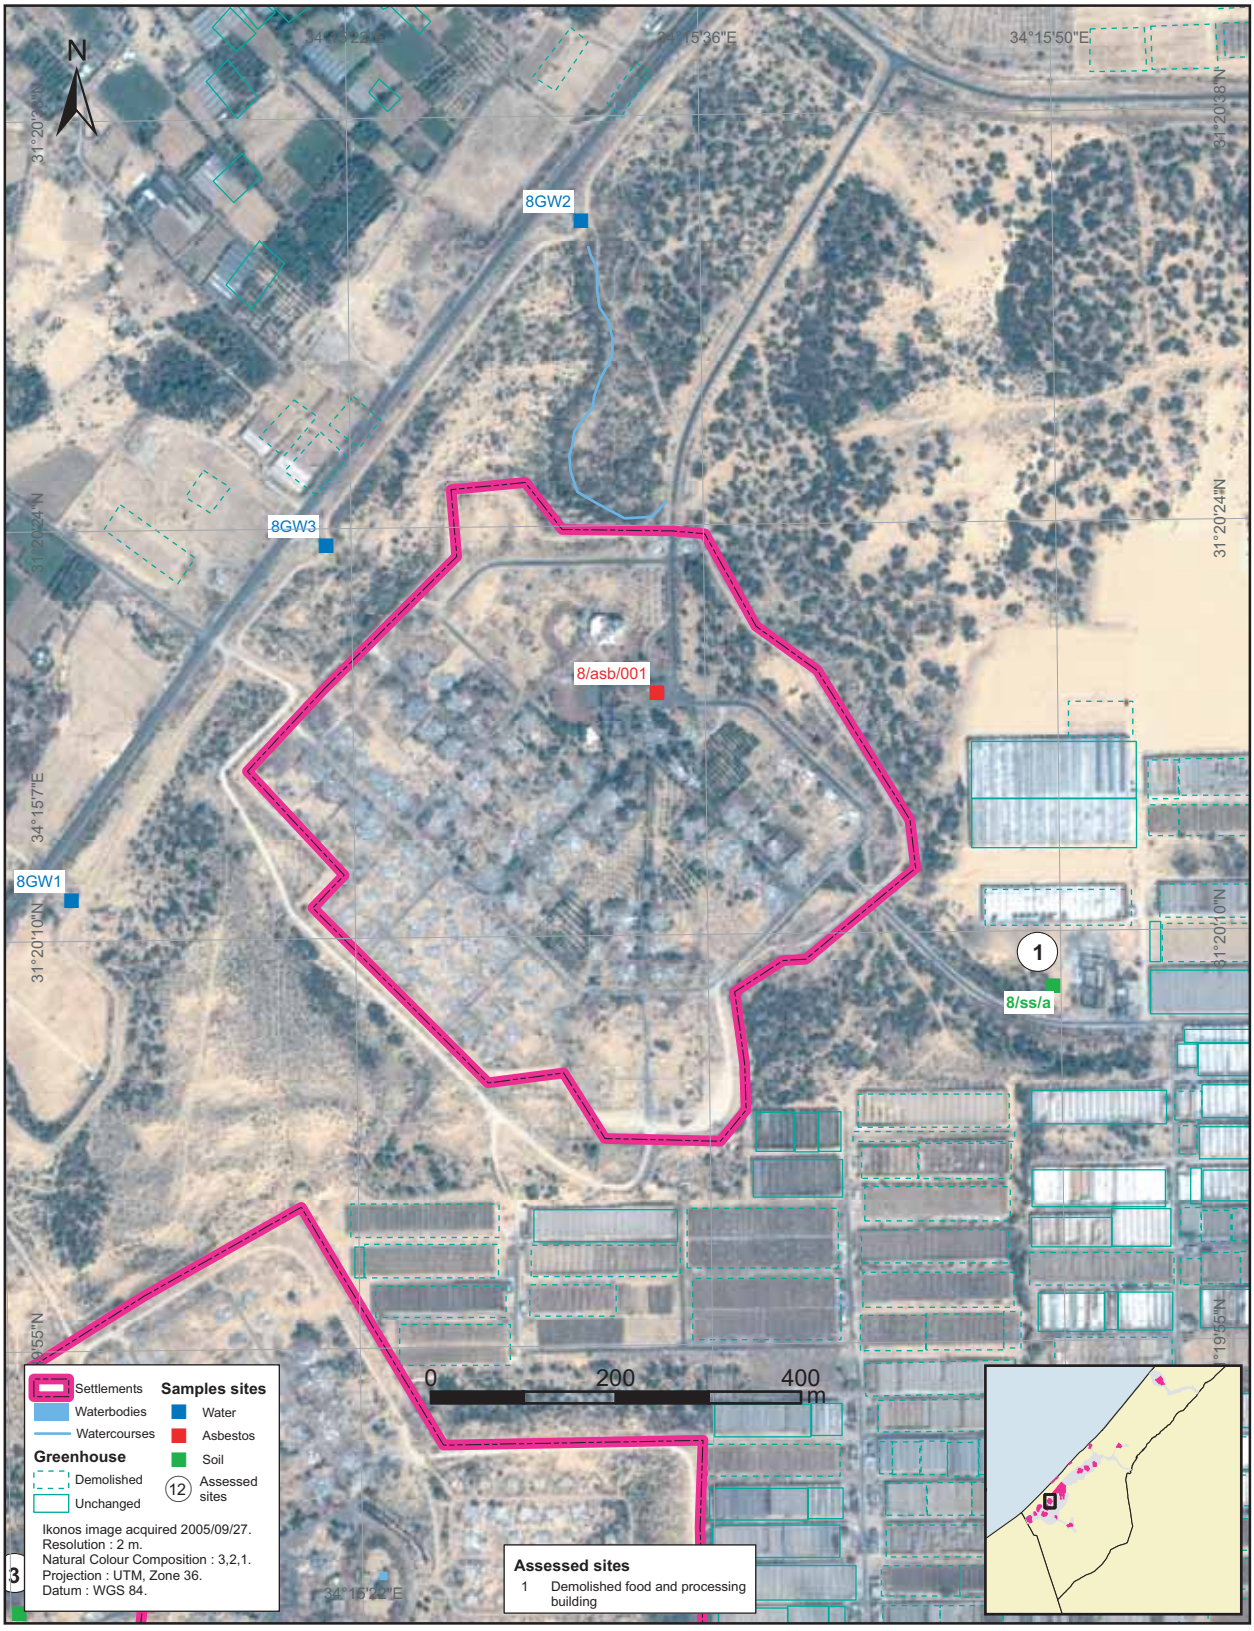
Map 13. Gan Or

Dumped waste at Gan Or. Although unsightly, contamination was minimal

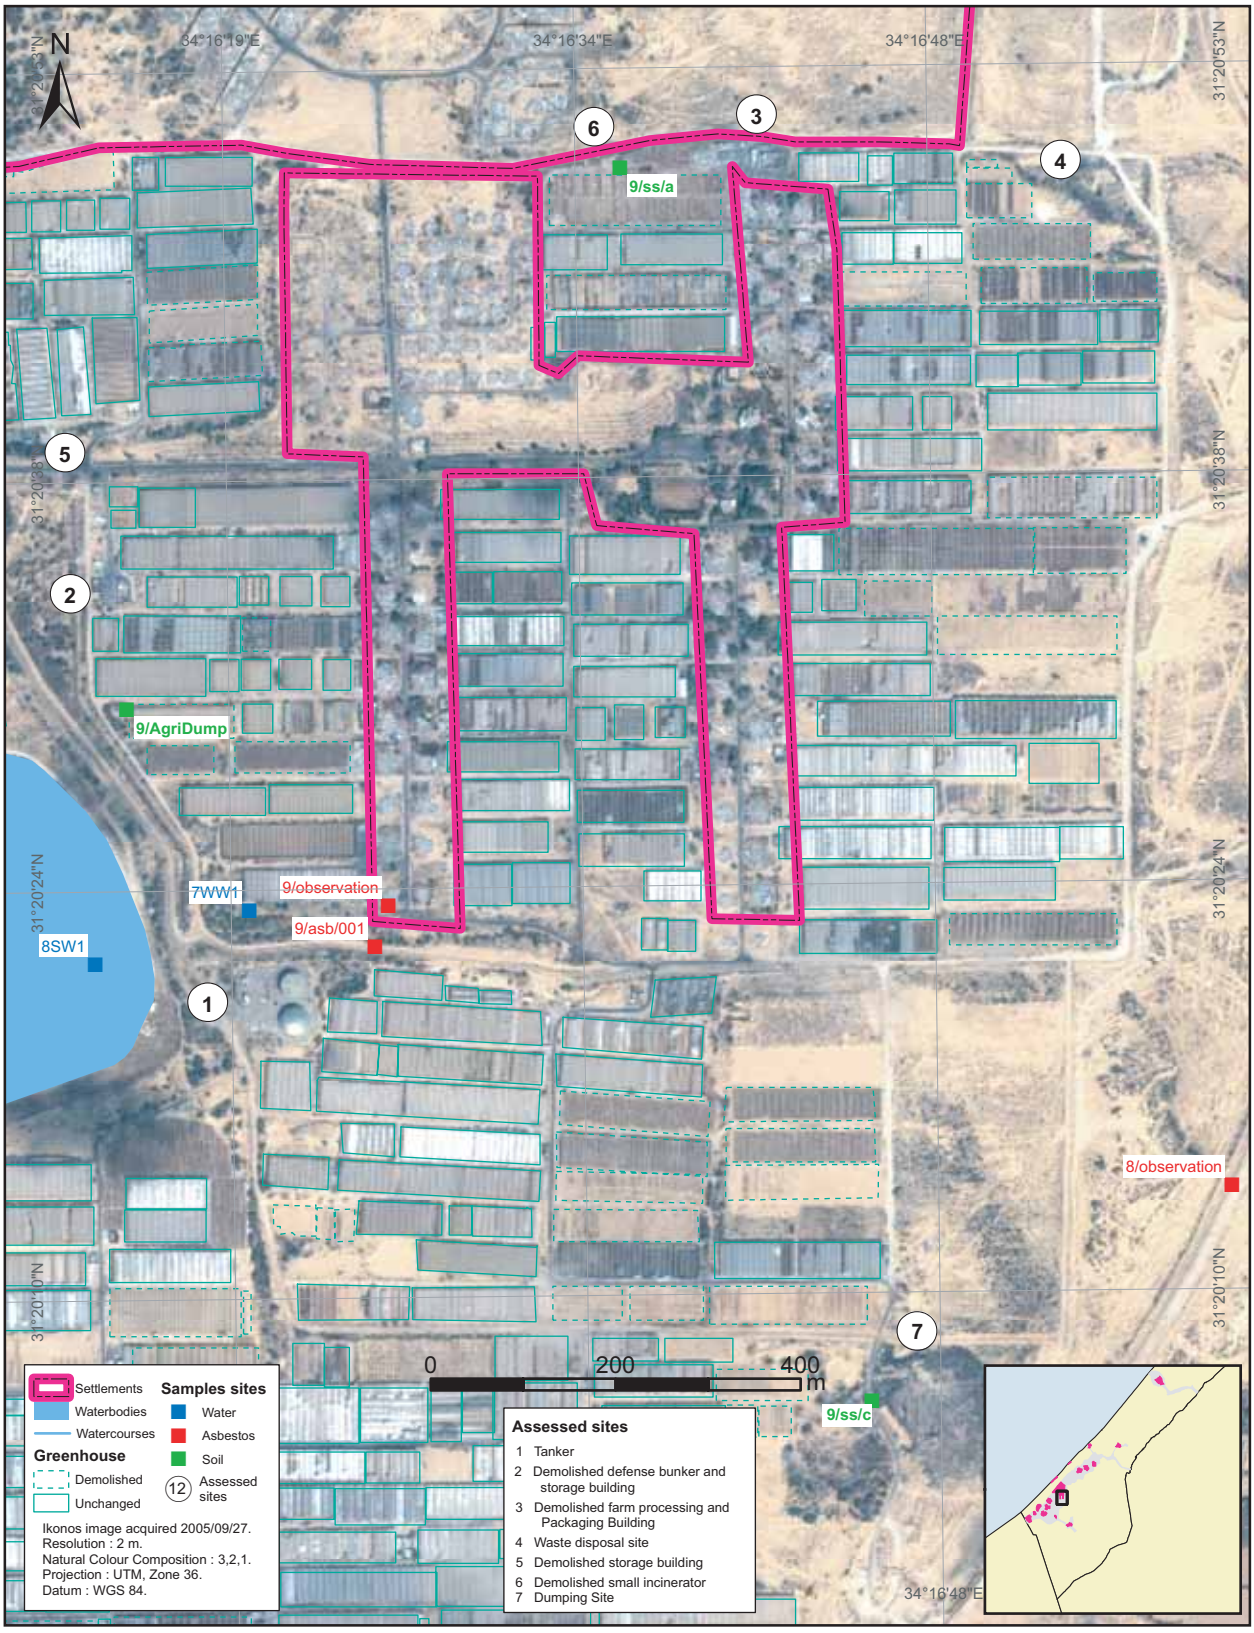
Map 14. Gadid

A soil sample consisting of fine-grained black grey ash with clinker was recovered from the face of the disposal area. Significant deposits of mounded fertilizer wastes, as well as domestic refuse (food cans), smaller volumes of clinical waste (bandages) and some industrial materials (paint cans, bags) were present.

1. Prior to the disposal and reuse of the demolition waste, asbestos should be identified and sorted out.

2. The material identified as ash (Location C), should be collected and transported to a central storage area for further treatment and disposal.

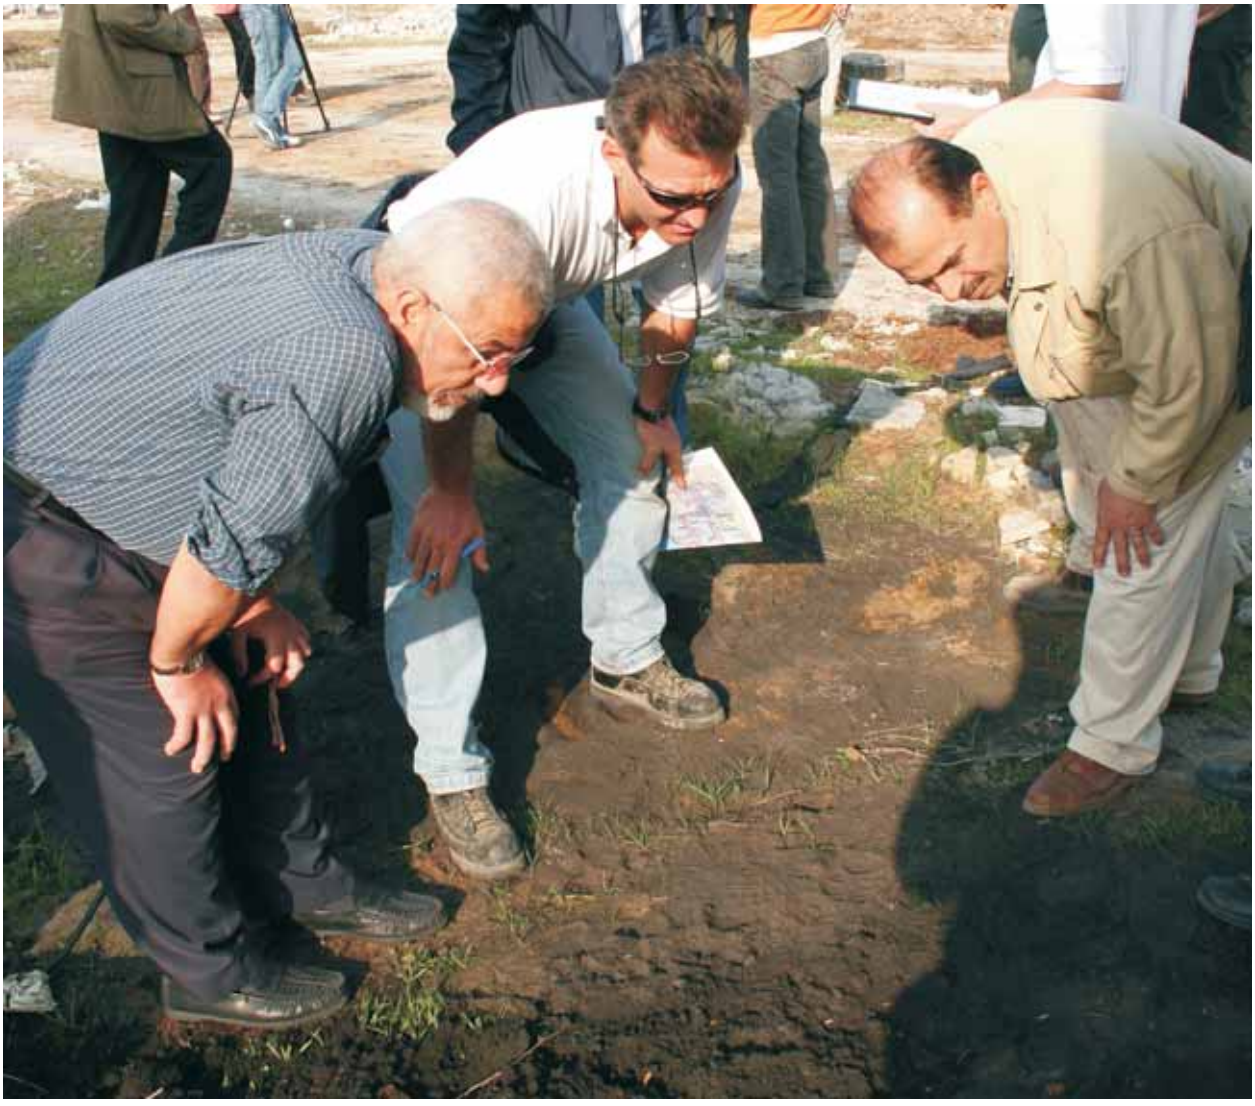
UNEP and Palestinian experts examining a soil sampling location at Gadid

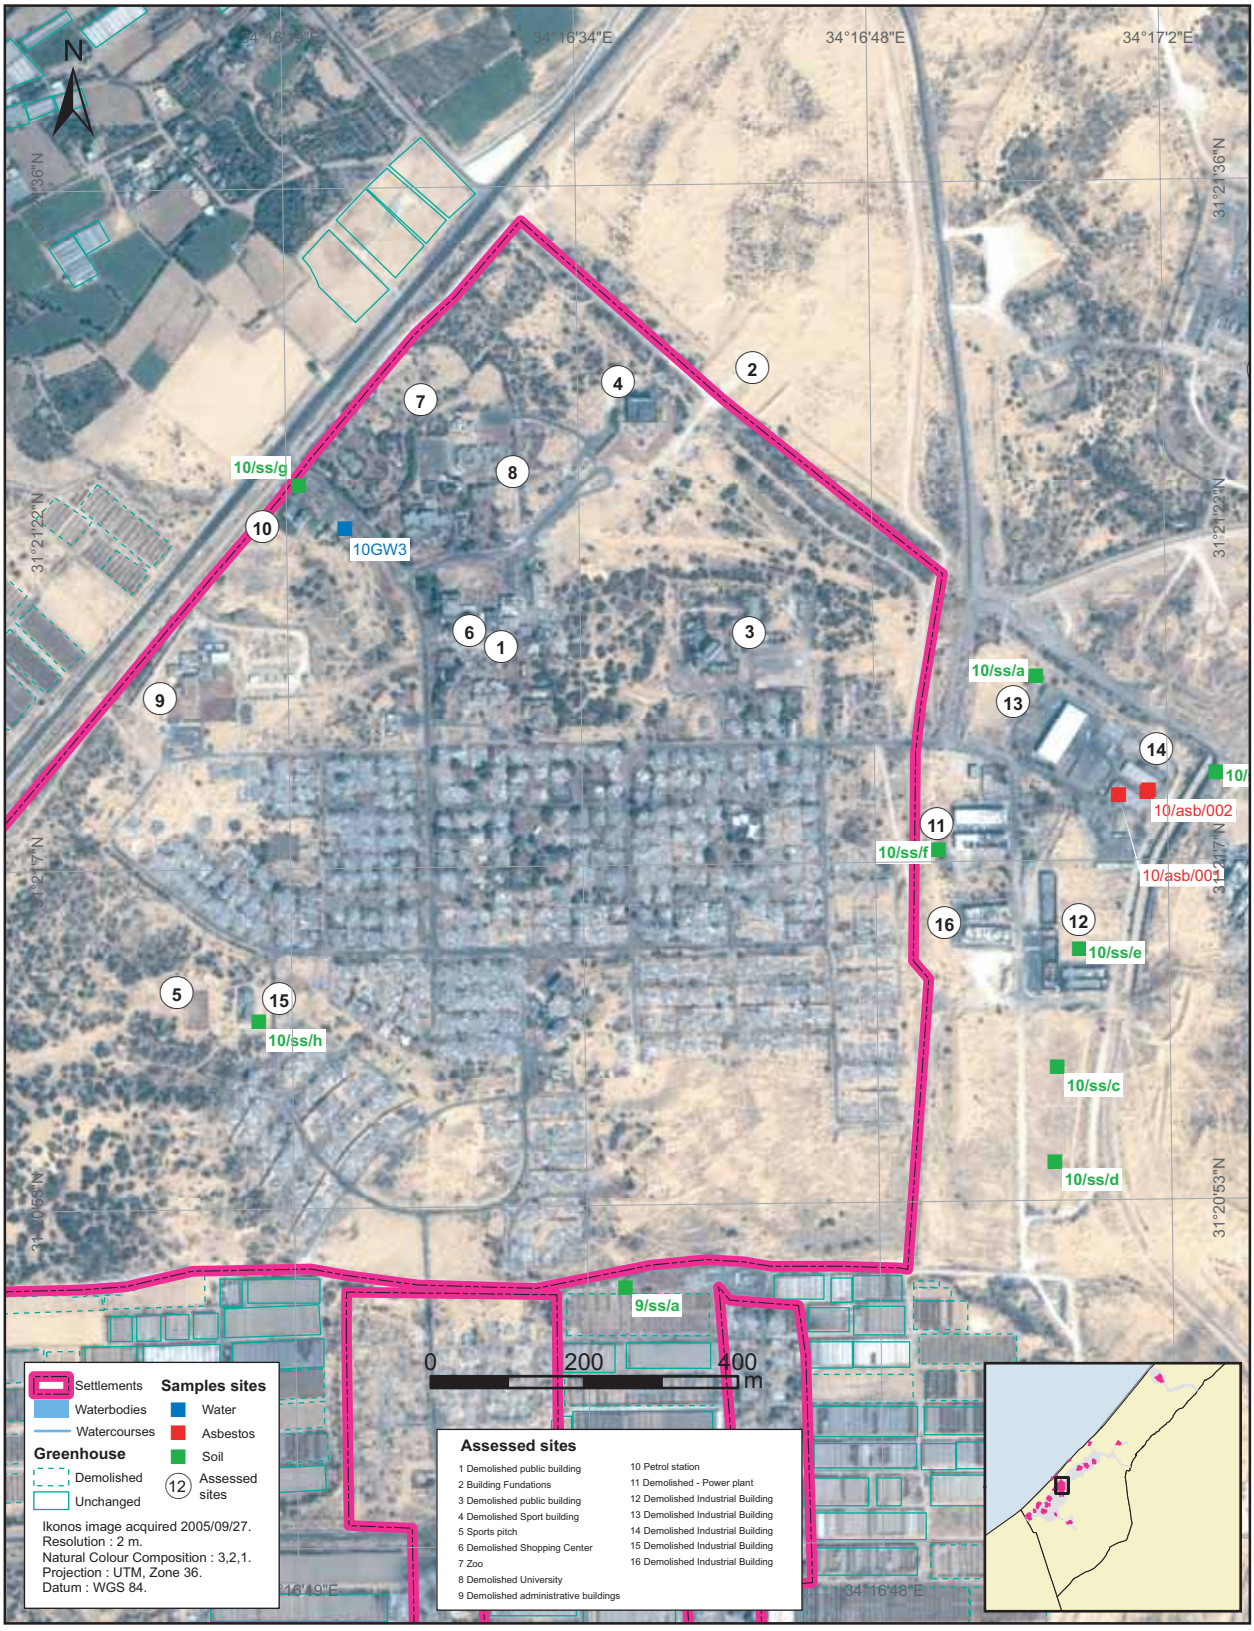
Map 15. Neve Dkalim

This area was not sampled but was considered important for waste disposal issues. It represented a large area (some 500m^2) of impact from waste materials deposited over the road's edge and the adjacent natural escarpment. These materials included a large proportion of organic materials (straw and plant bedding) as well as plastic sheeting, clearly from the greenhouses to the south.

Large area of some 500 m² impacted by waste materials, at location B in Nieve Dkalim

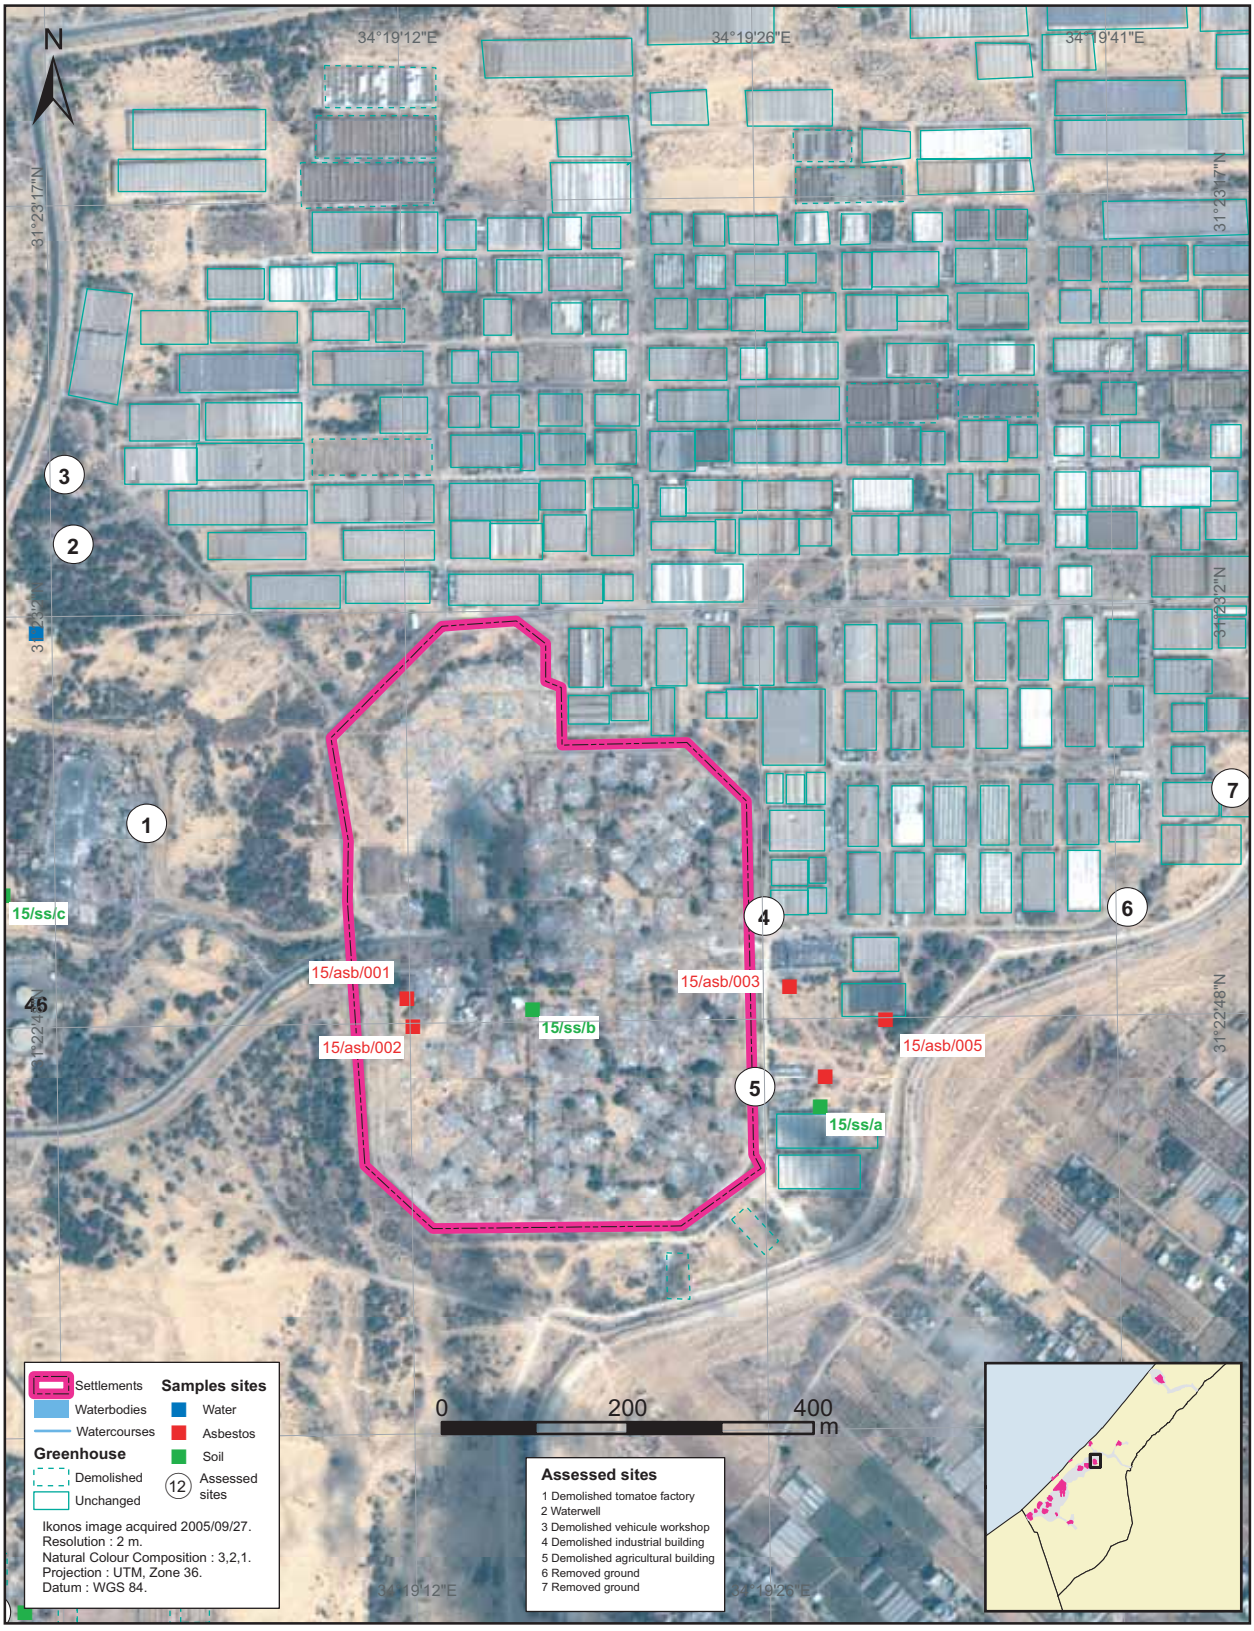
Map 19. Netser Hasani

A greenhouse heating unit with localized oil spill in the background

The oil was only found to a depth of 0.2m below the surface, composed of a medium-grained "clean" sand. Given the limited depth profile of the contamination as shown by visual observation, it was felt that there was no need to extend the depth of the sampling.

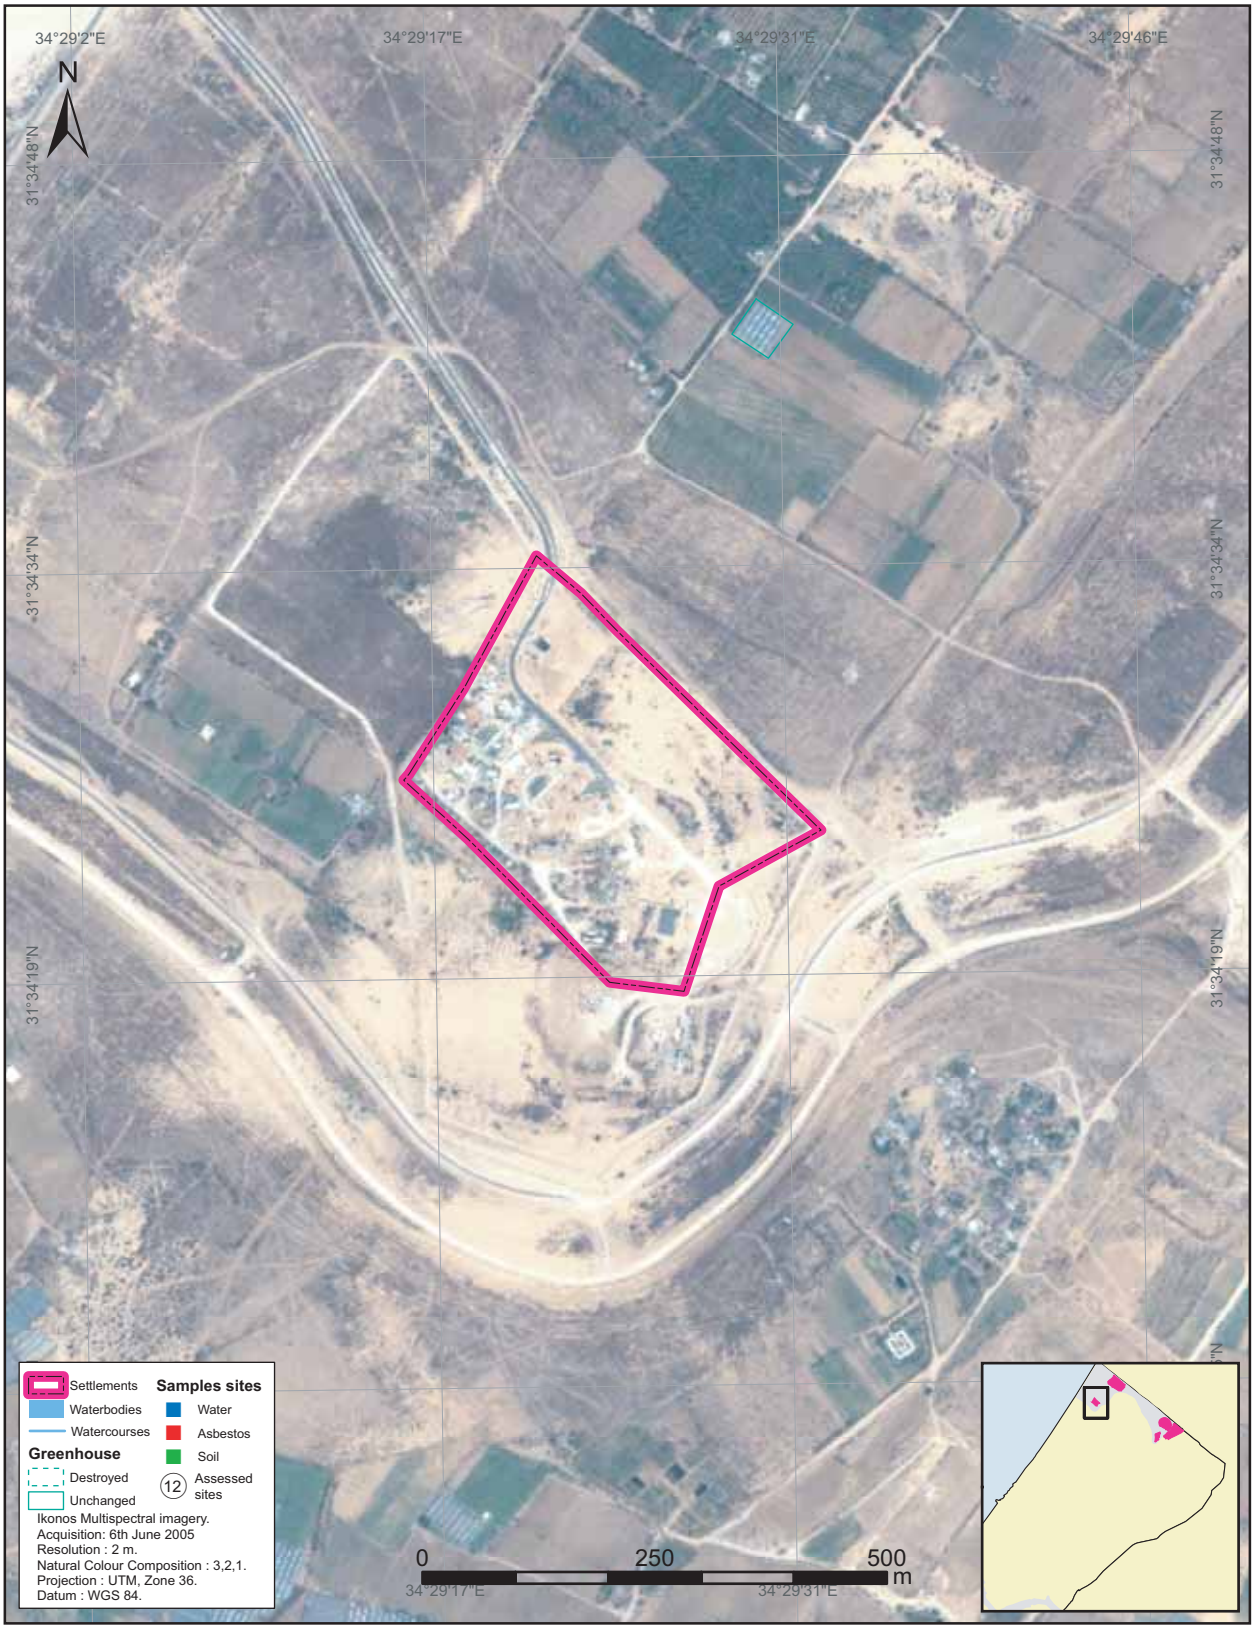
Map 23. Dugit

Rubble removal is the primary problem in Dugit

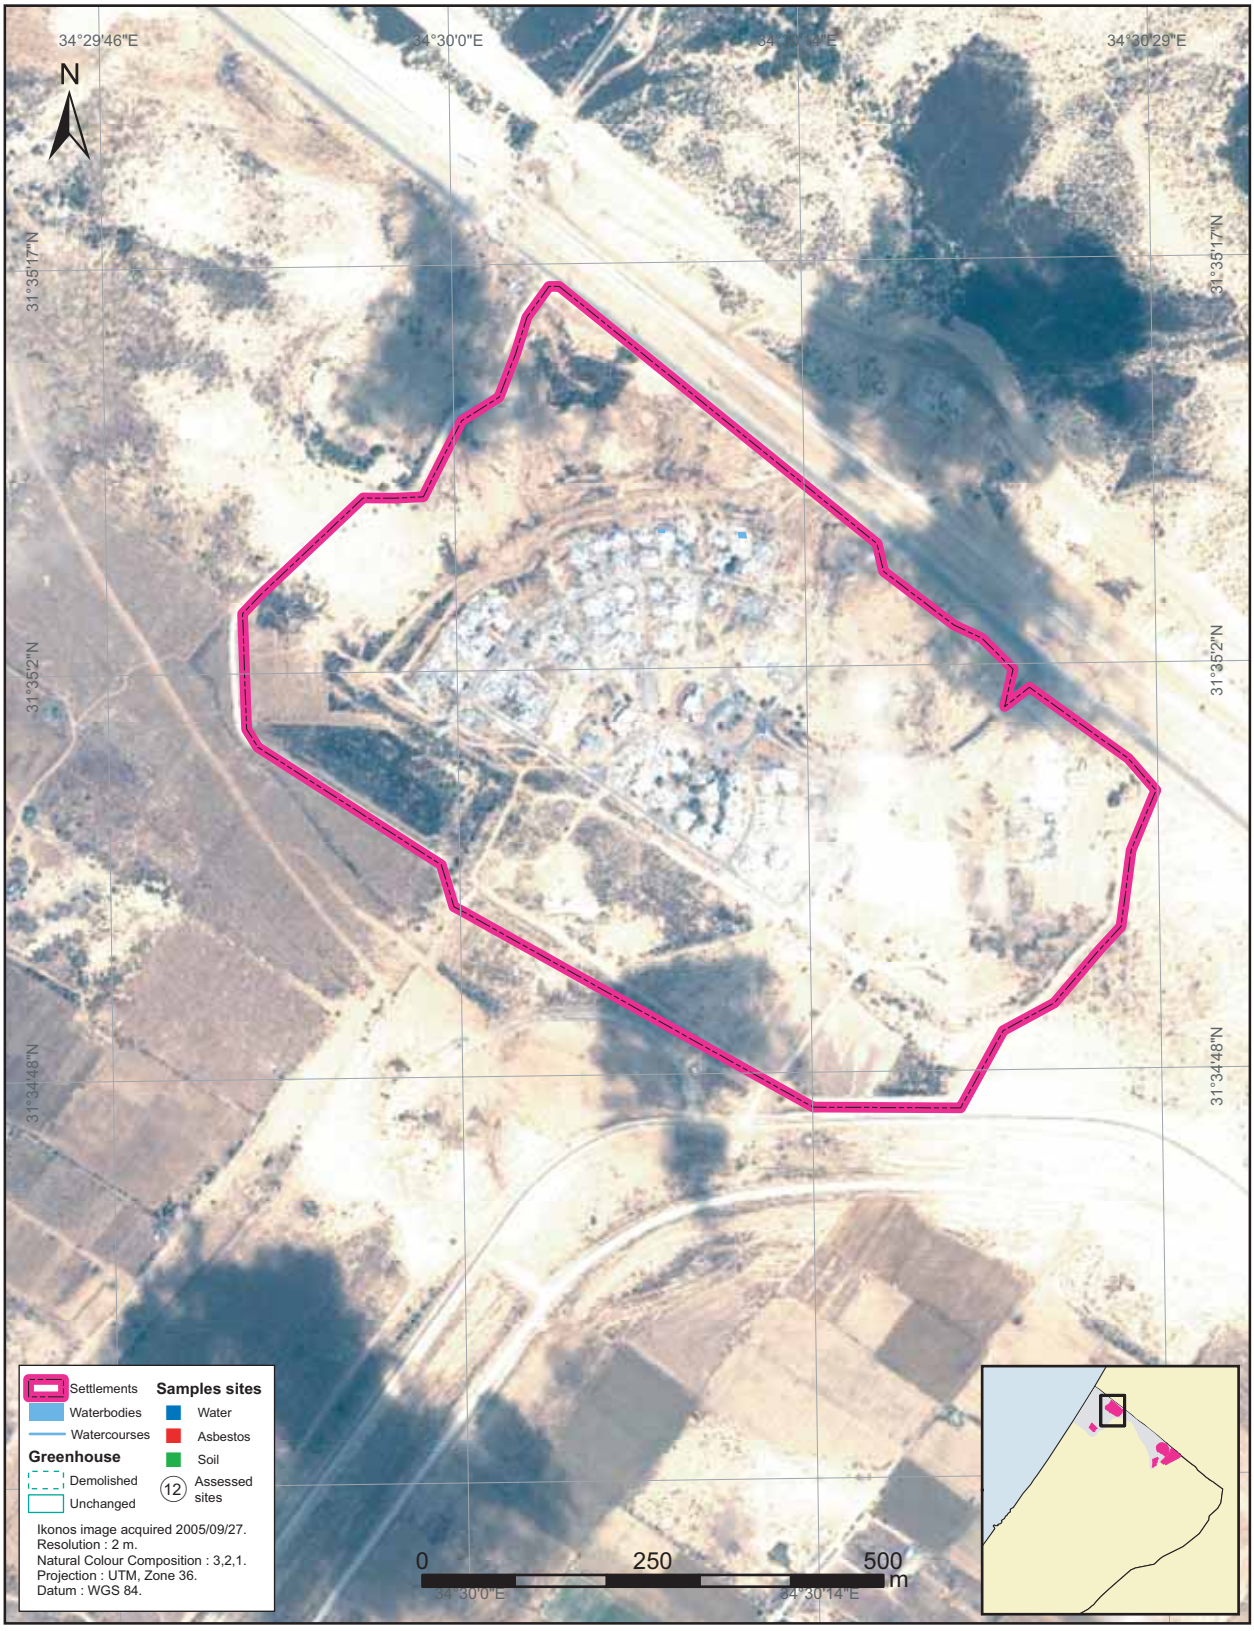
Map 24. Elei Sinai

As with the other small settlements, the main issue was rubble
