Environmental Assessment of the Areas Disengaged by Israel in the Gaza Strip

United Nations Environment Programme

First published in March 2006 by the United Nations Environment Programme.

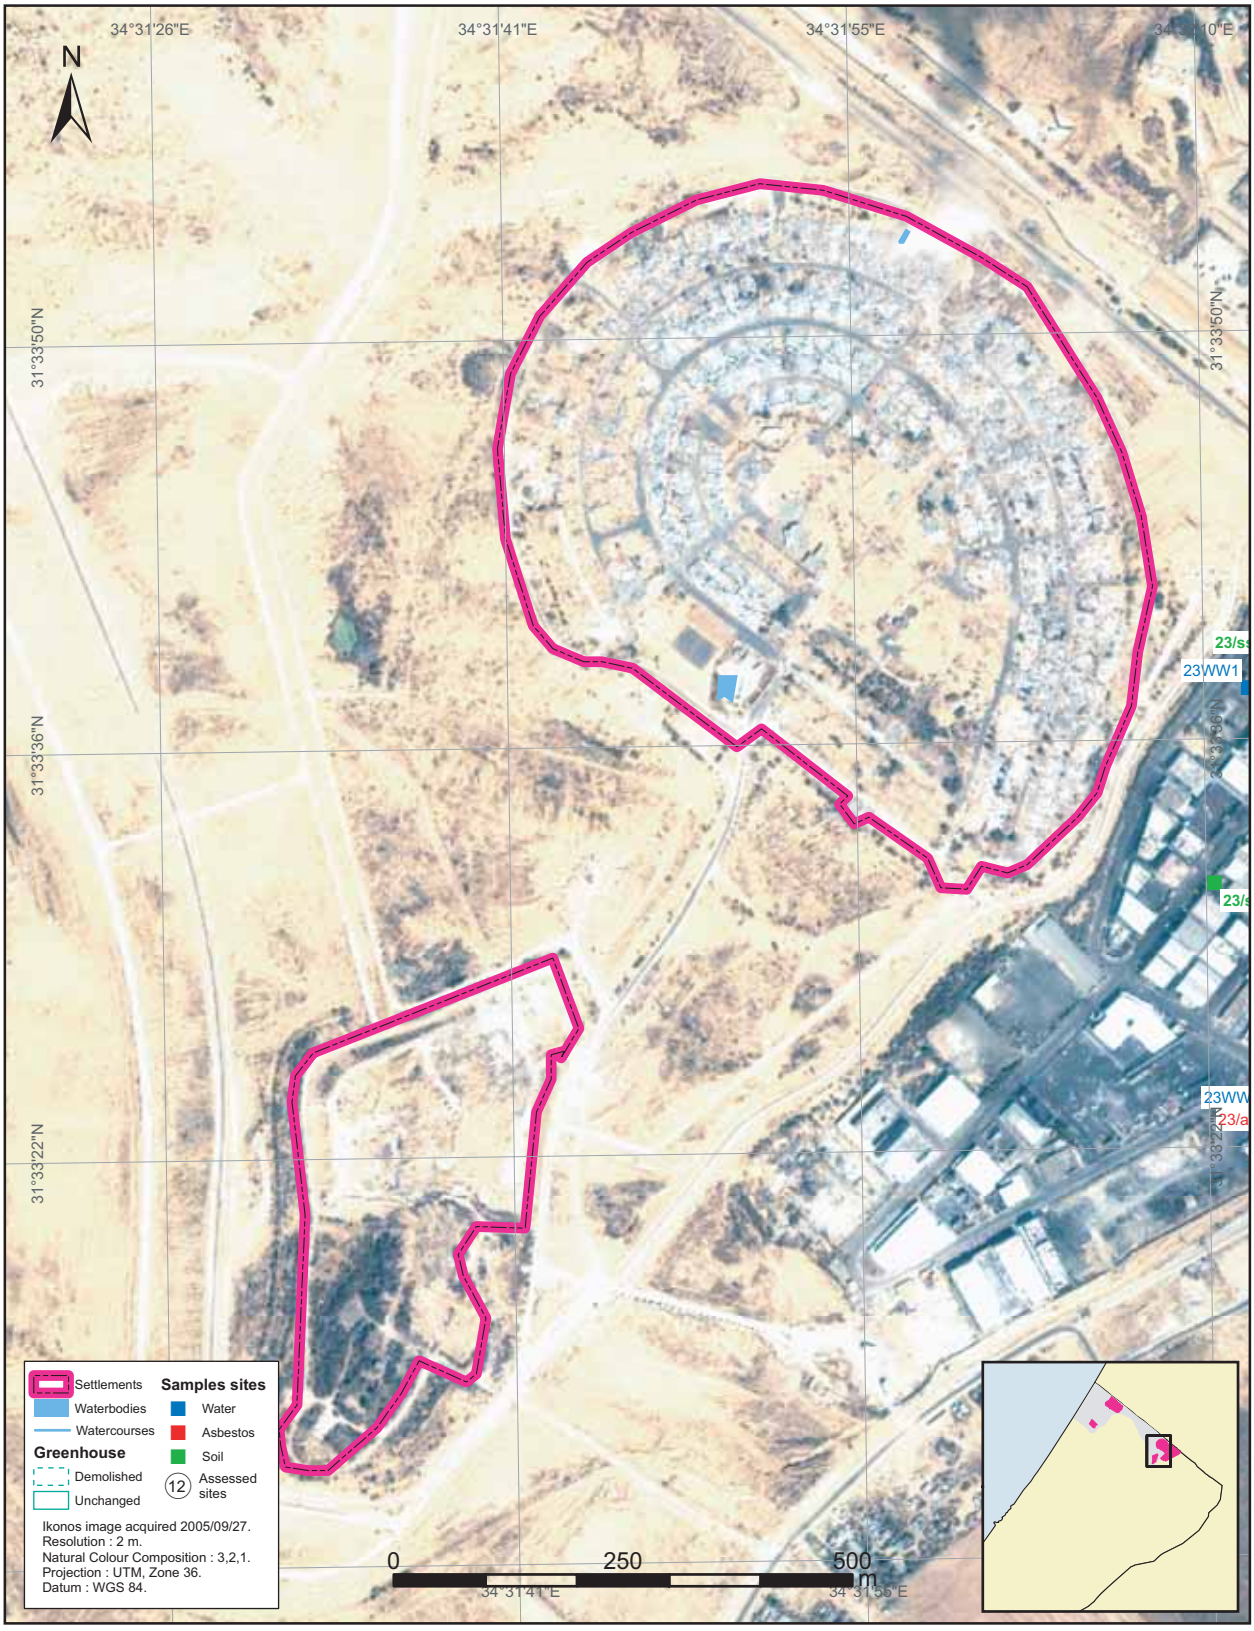
Map 25. Nisanit / New Nisanit

Abandoned sports and leisure facility in Nisanit
